Friends of the Eel River Blockwater Investigation Final Memo

FOER Blockwater Investigation Final Memo

Prepared by: Alison O'Dowd and William Trush
Humboldt State University River Institute

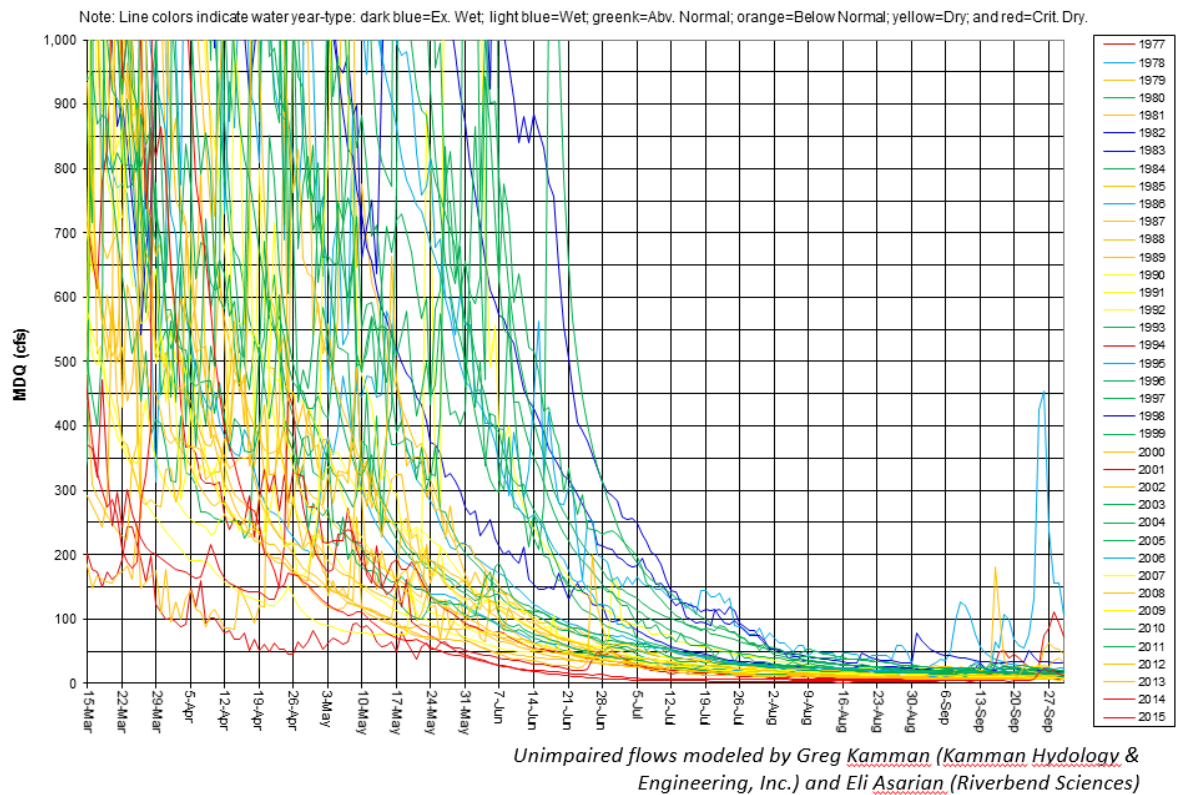
Figure 6. Estimated **unimpaired** flow below Van Arsdale (WY1977-WY2014). Unimpaired flows were modeled by Greg Kamman (Kamman Hydrology Engineering, Inc.) and Eli Asarian (Riverbed Sciences).

Unimpaired flows were modeled by Eli Asarian (Riverbend Sciences) to show what the natural hydrograph would have looked like over time at Van Arsdale if the Potter Valley Project was not in place (E. Asarian, 2015, unpublished data). The estimated unimpaired flows between WY1977 and WY2014 show a gradual decline in streamflow between March and September (Figure 6). In contrast, the impaired hydrographs between WY1977 and WY2014 show a sharp drop-off in flow by the end of June even in the wettest years (Figure 7).

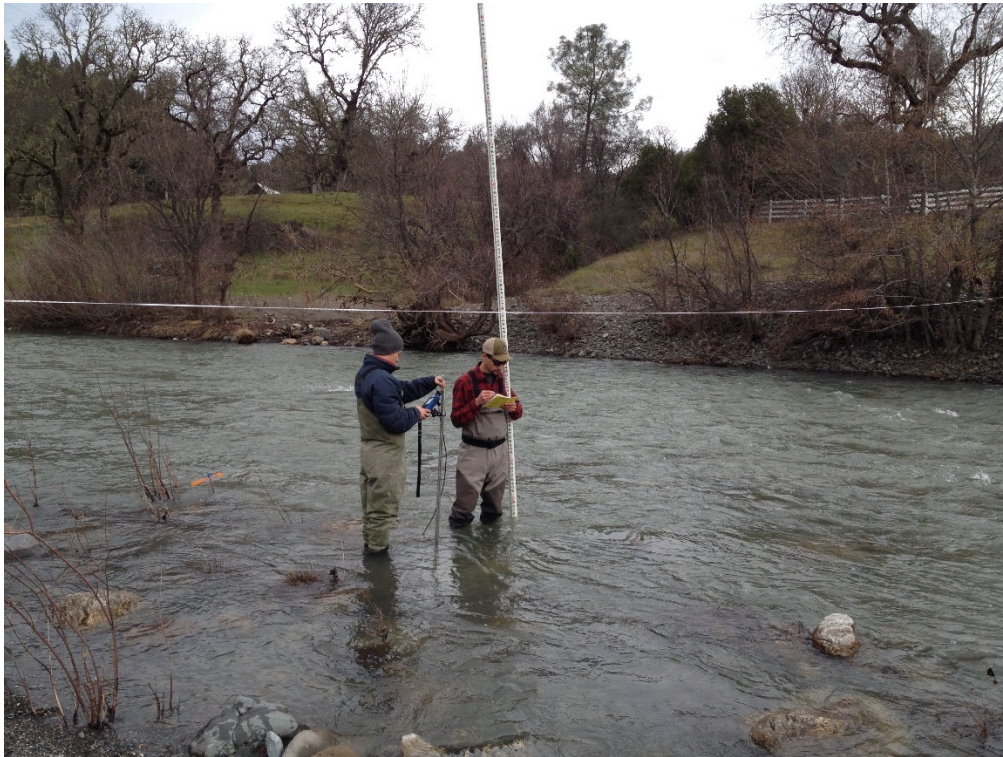
Figure 9. Humboldt State University undergraduate Environmental Resources Engineering majors Faith Neff and Dustin Revel measure velocity and an elevational profile along a cross section at the Hearst site on 1/15/15. Photo by A. O'Dowd.

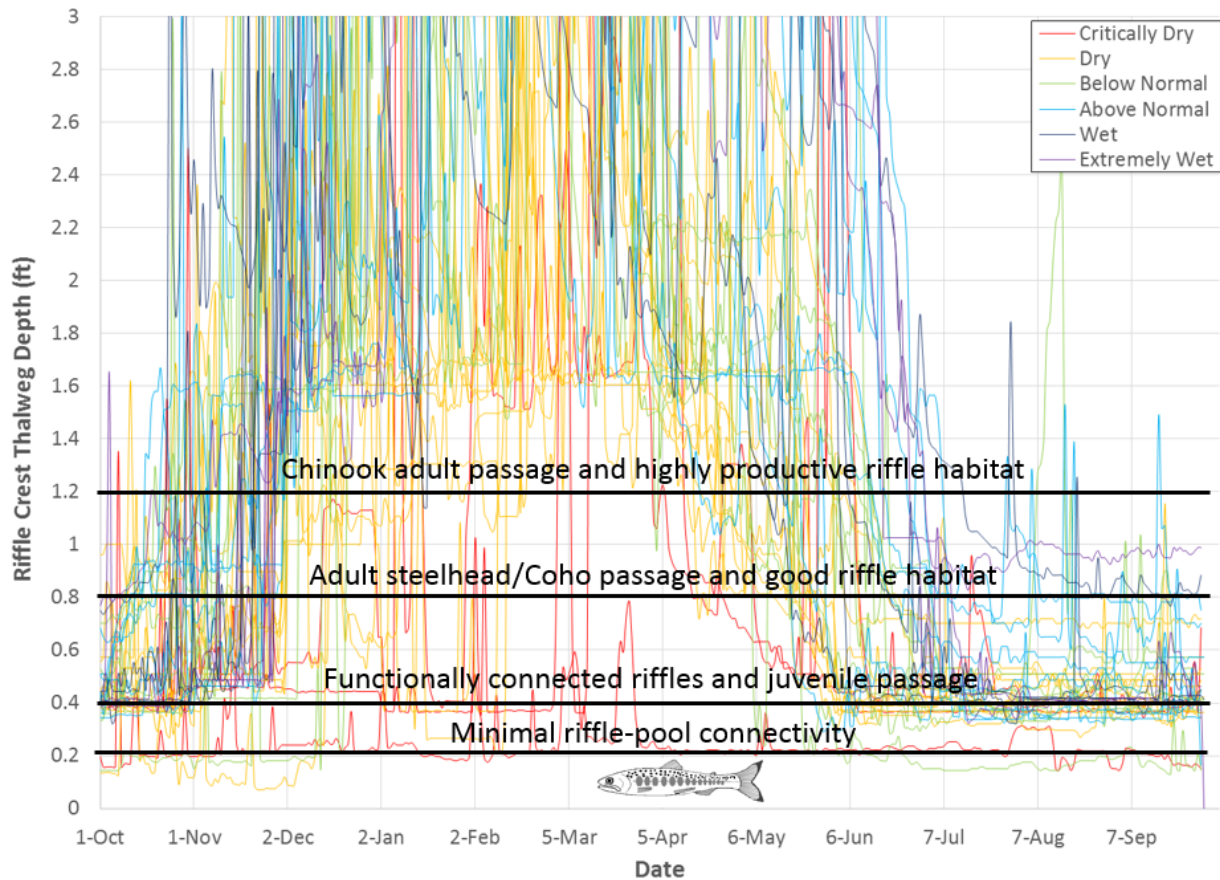
Figure 14. Riffle crest thalweg depths (based on **impaired** flow releases from Cape Horn Dam) on the Mainstem Eel River at Hearst (WY1977-WY2011).

A rating curve was created using USGS flow and stage data recorded on the Mainstem Eel River at Hearst in WY1911 (Figure 13). WY1911 was used to construct the rating curve because it had an adequate number of flow and stage measurements available. The rating curve equation ($y = 0.1127x^{0.5394}$) was used to convert modeled unimpaired flow data into riffle crest thalweg (RCT) depths at this site. Riffle crest thalweg depths were then plotted as a 'spaghetti graph' in which each water year was plotted separately on the same graph for both the impaired (Figure 14) and unimpaired flows (Figure 15). Annual hydrographs were color-coded to show extremely wet, wet, above normal, below normal, dry and critically dry years. An image of a juvenile salmonid and the four biologically-relevant RCT depth thresholds from Table 3 were superimposed onto these graphs to show when and how often these thresholds would have been crossed in WY1977-WY2014 in an unimpaired (no dam, Figure 14) and impaired (Figure 15) scenario.

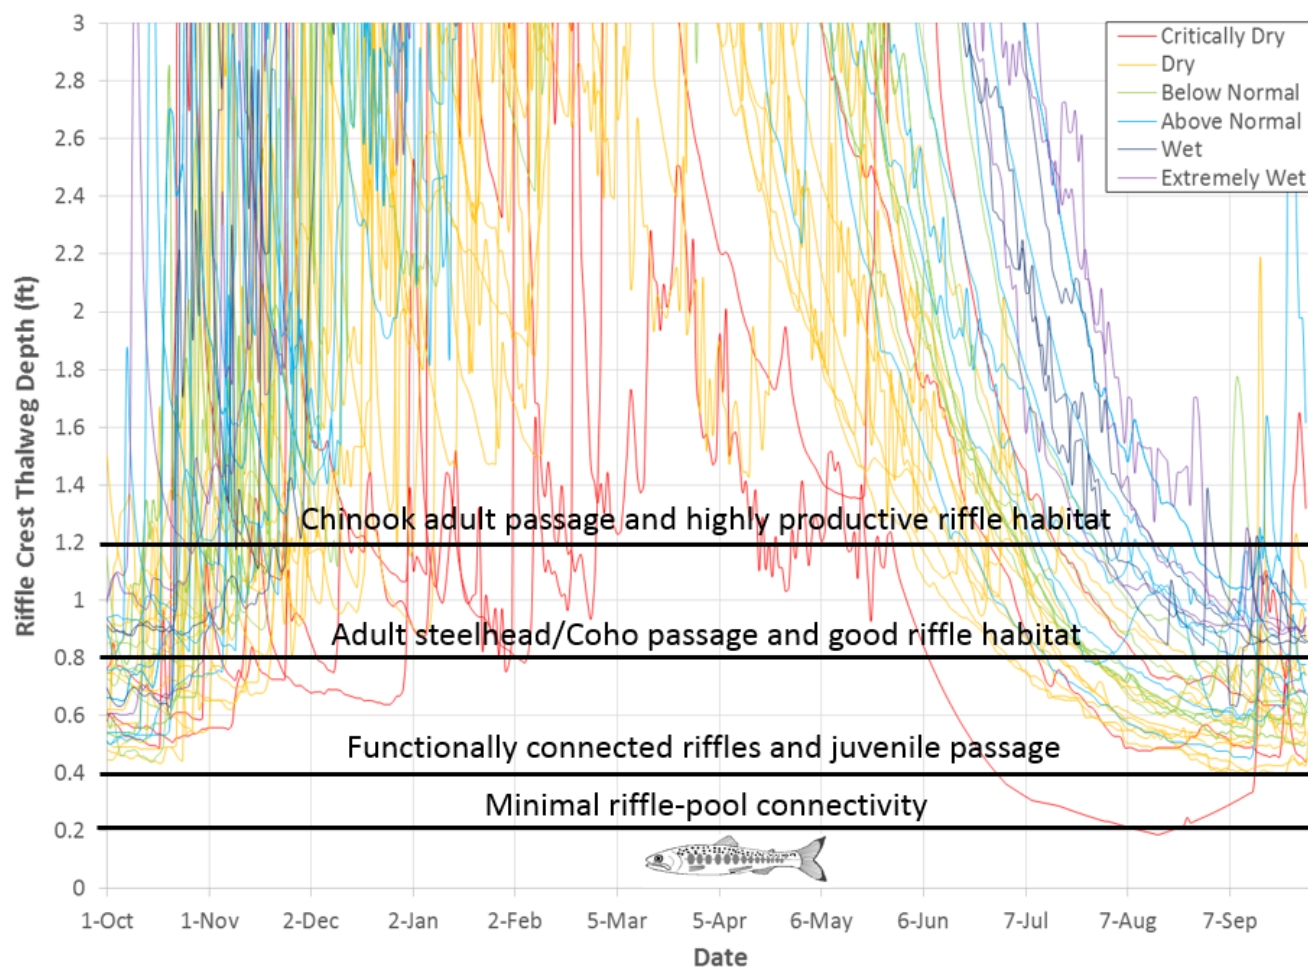
Figure 15. Estimated **unimpaired** riffle crest thalweg depths on the Mainstem Eel River at Hearst (WY1977-WY2014).

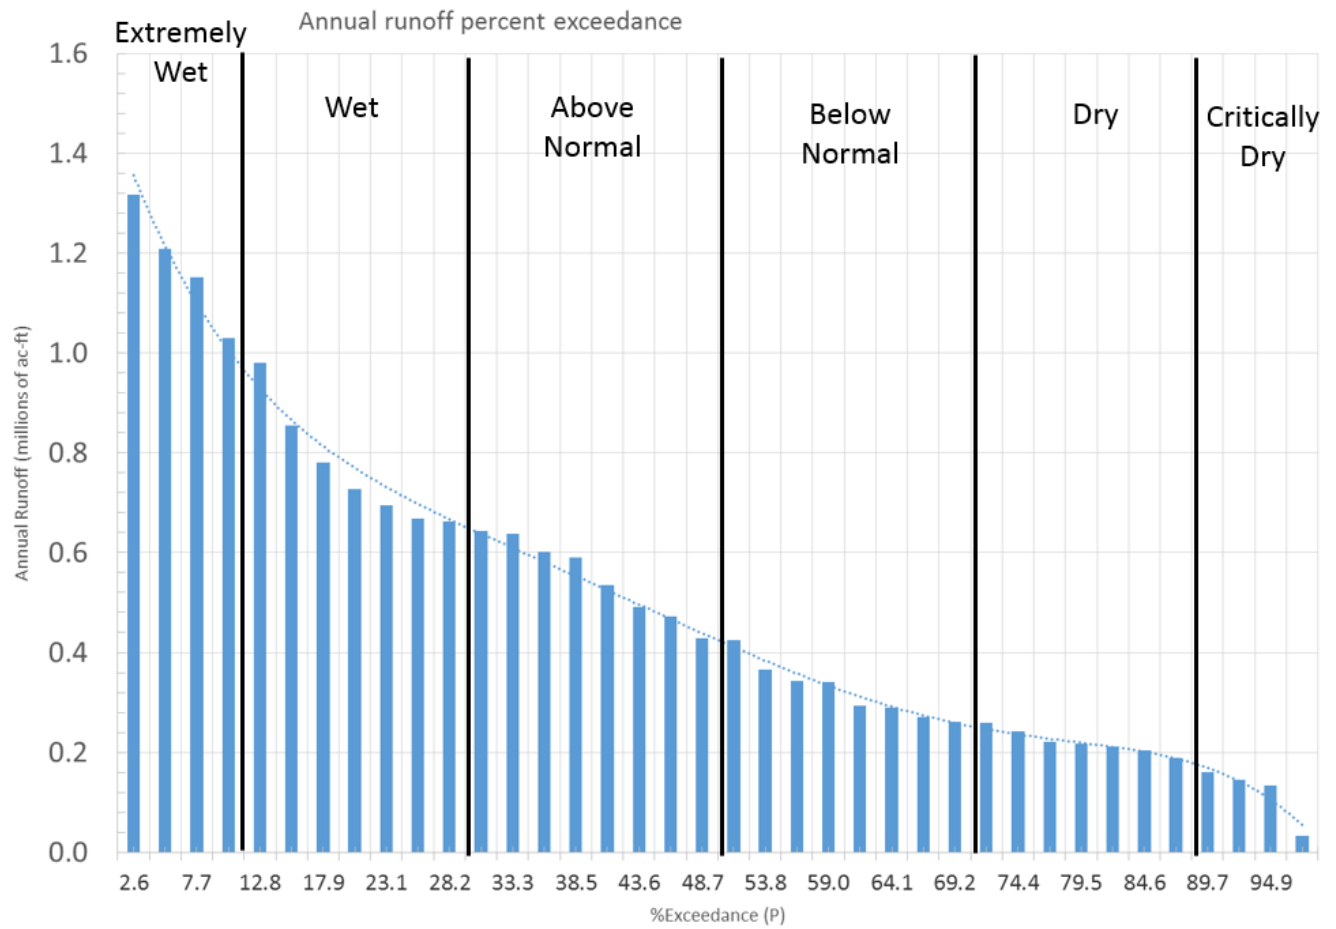
Figure 16. Annual runoff percent exceedance curve based on unimpaired flow data at Van Arsdale with categories from 'extremely wet' to 'critically dry'.

An annual runoff percent exceedance graph was created using the modeled unimpaired runoff data. Total runoff (cfs) for each water year was calculated and then converted to total acre-feet per year (Figure 16). Years were ranked from wettest to driest years by total acre-feet (Table 4). The percent exceedance values (P) were used to examine at the time of year when the four riffle crest thalweg thresholds were crossed.

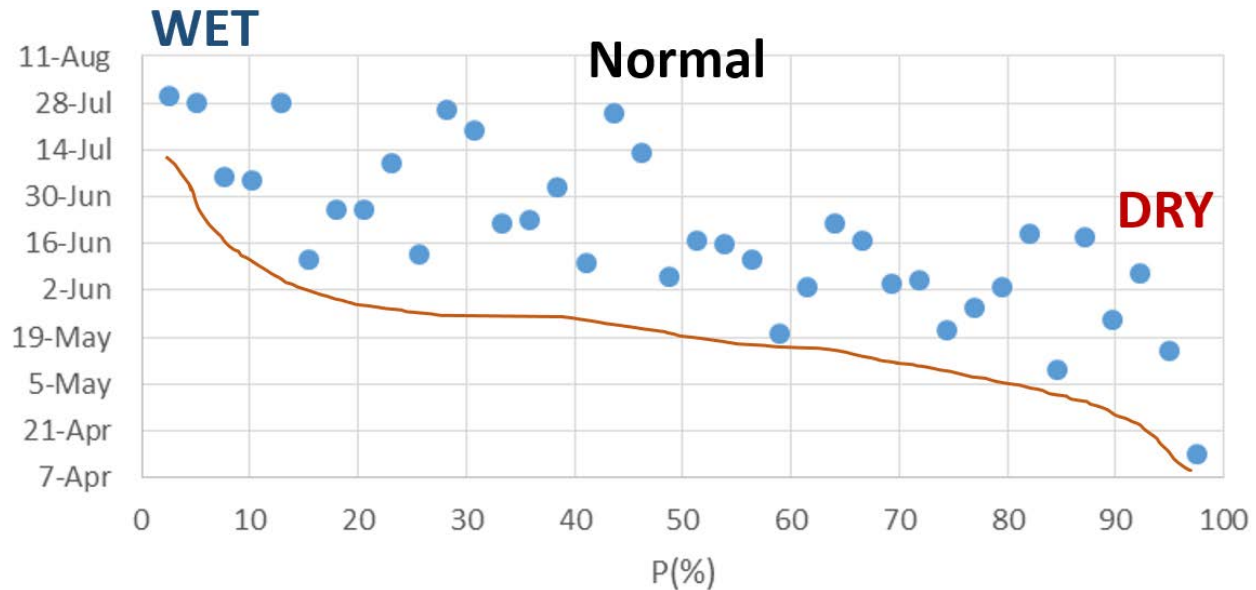
Figure 17. The date when the riffle crest thalweg (RCT) depth crossed a threshold of less than 1.2 feet during the spring recession limb of the modeled **unimpaired** flow at Van Arsdale (WY1977-WY2014). The orange line shows the lower boundary of these dates.

Four graphs were created to show the date of each water year between WY1977-WY2014 when a riffle crest depth threshold was crossed during the spring recession limb. The first graph (Figure 17) shows that in ‘extremely wet’ years ($P < 10\%$) the riffle crest thalweg depth (RCT) was ≥ 1.2 feet until July and in “Normal” ($P = 50\%$) years this RCT depth persisted generally into early June. Therefore, for dam releases to allow highly productive riffle habitat to occur on the Mainstem Eel downstream of Van Arsdale reservoir, a release of a minimum of 80 cfs from Cape Horn Dam into early June would be needed for most years (as would occur in “Normal” ($P = 50\%$) years in an unimpaired scenario).

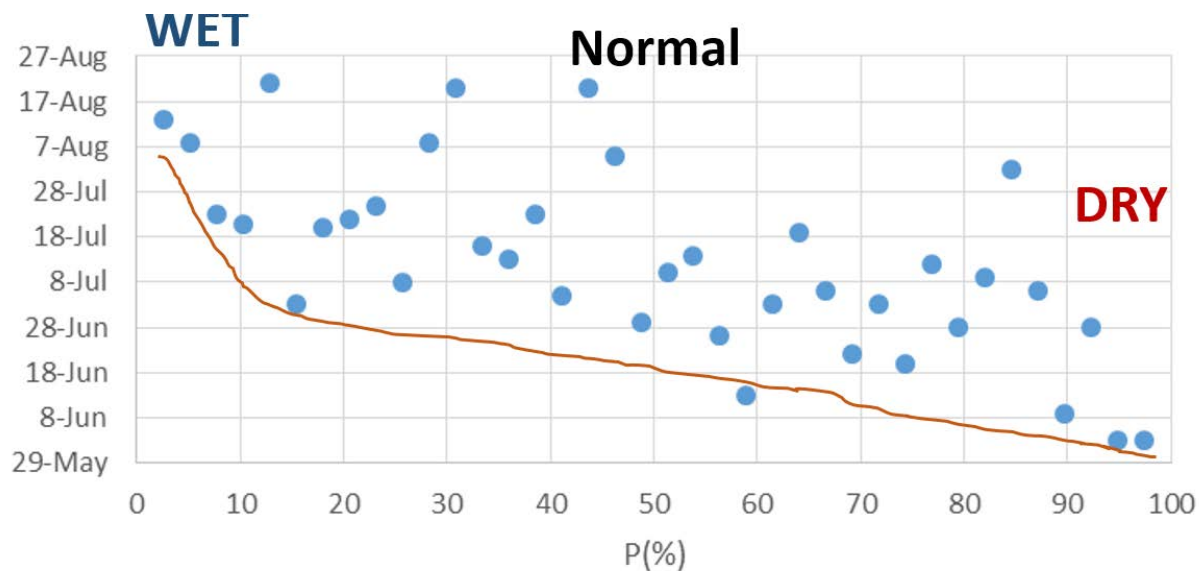
Figure 19. The date when the riffle crest thalweg (RCT) depth crossed a threshold of less than 0.8 feet during the spring recession limb of the modeled **unimpaired** flow at Van Arsdale (WY1977-WY2014). The orange line shows the lower boundary of these dates.

Moreover, in the modeled unimpaired flow data a riffle crest depth of 0.8 ft (for ‘good’ riffle habitat) was maintained in “wet” (P<10%) years until mid-July and early-August (Figure 19). In “Normal” years the riffle crest depth was >0.8 feet until mid- to late-June. Therefore, dam releases from Cape Horn Dam should release a minimum of 38 cfs in most years through mid- to late-June in order to maintain ‘good’ riffle habitat for rearing juvenile salmonids.

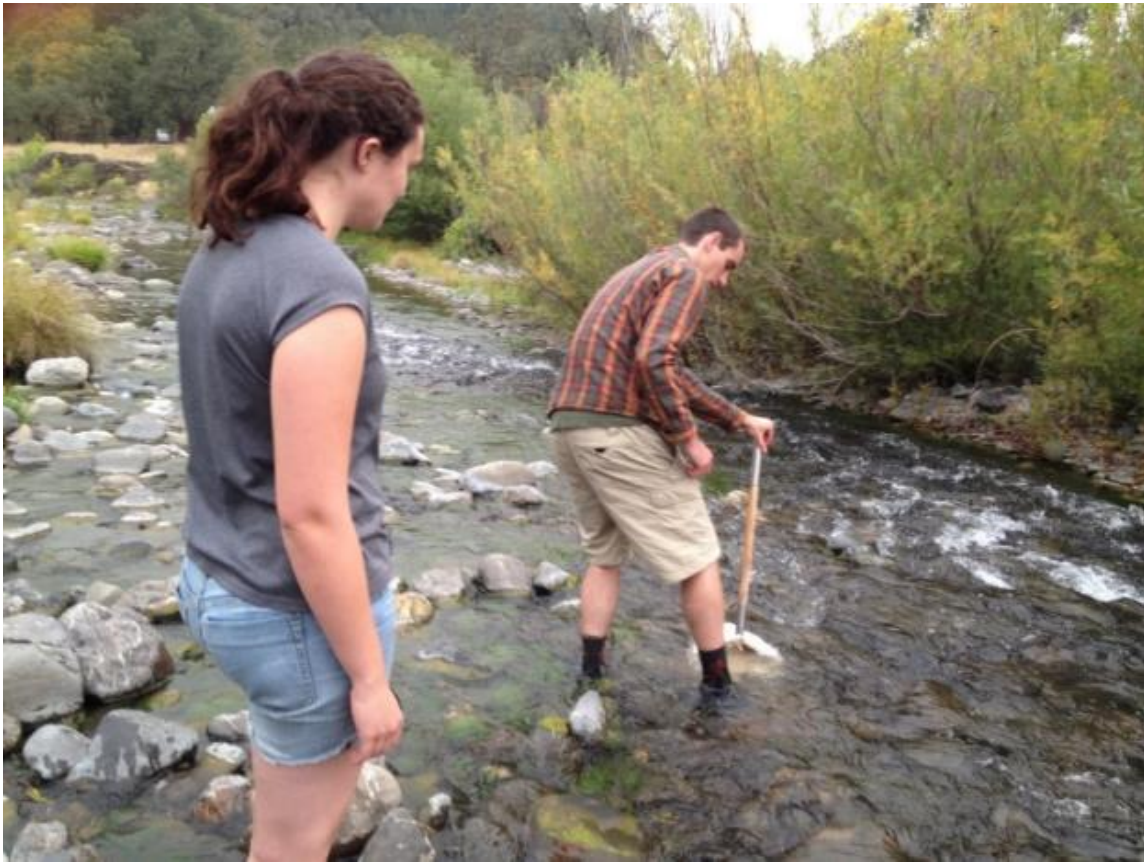
Figure 26. Humboldt State University undergraduate Environmental Science majors Rachel Klassen and Alder Gustafson use a D-frame net to sample benthic macroinvertebrates at the Hearst site riffle crest on 9/13/15. Photo by A. O'Dowd.

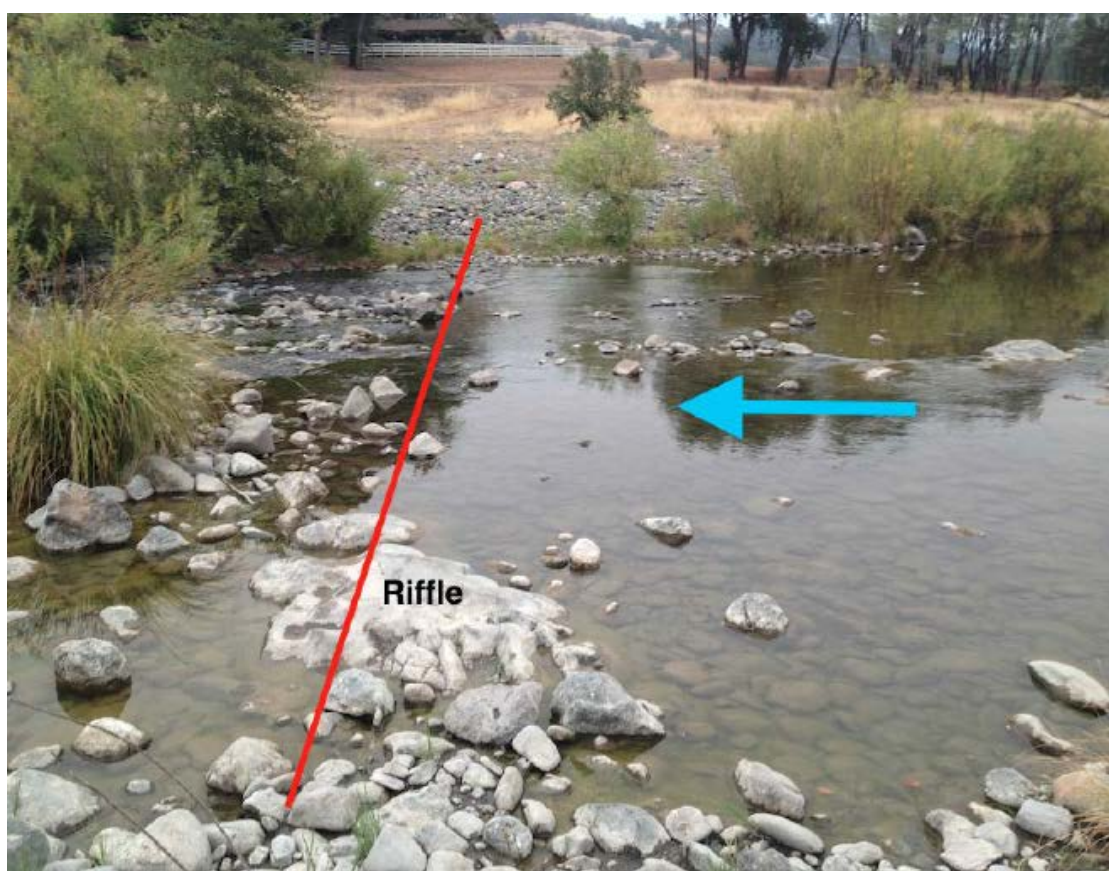
Figure 27. Hearst site riffle transect looking at right bank. Blue arrow indicates direction of flow. Photo taken by A O'Dowd 9/13/15.

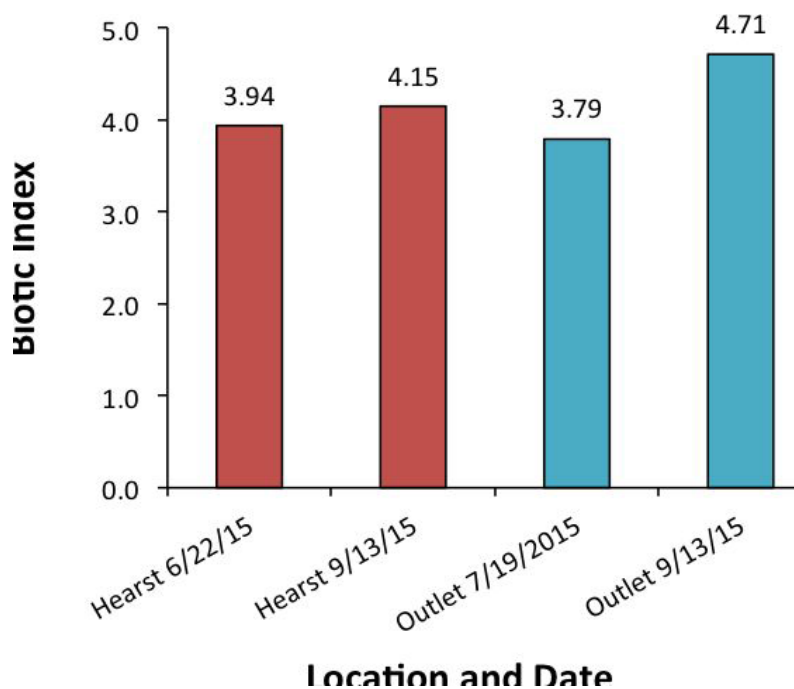
Figure 28. Biotic index for Hearst and Outlet sites.

The benthic macroinvertebrate study found that benthic invertebrate assemblages reflected good water quality overall, with low biotic index scores and high percentages of Ephemeroptera, Plecoptera, and Trichoptera (EPT) (Table 5). However, biotic condition and %EPT decreased over the summer season between June and September 2015, with a corresponding increase in percentage of tolerant invertebrates (Figures 28-30). The possible ecological reasons for this shift from sensitive to tolerant invertebrates include salmonid predation, benthic invertebrate life history/timing of emergence, invertebrate predation susceptibility, and hydrologic factors. A more rigorous study framework is needed to fully explain the complex relationship between flow and benthic macroinvertebrate community dynamics on the Eel River.

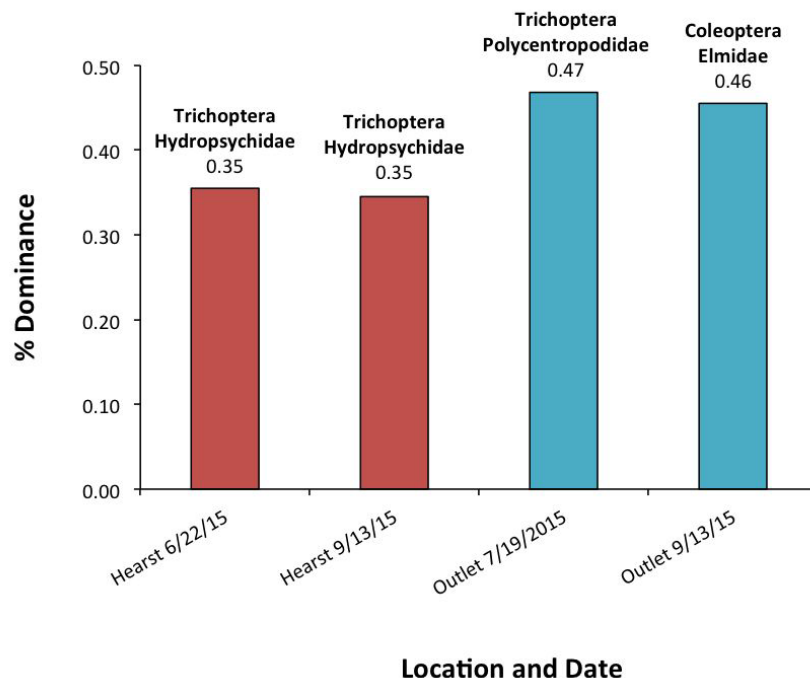
Figure 30. Percent dominance of taxa at Hearst and Outlet sites.

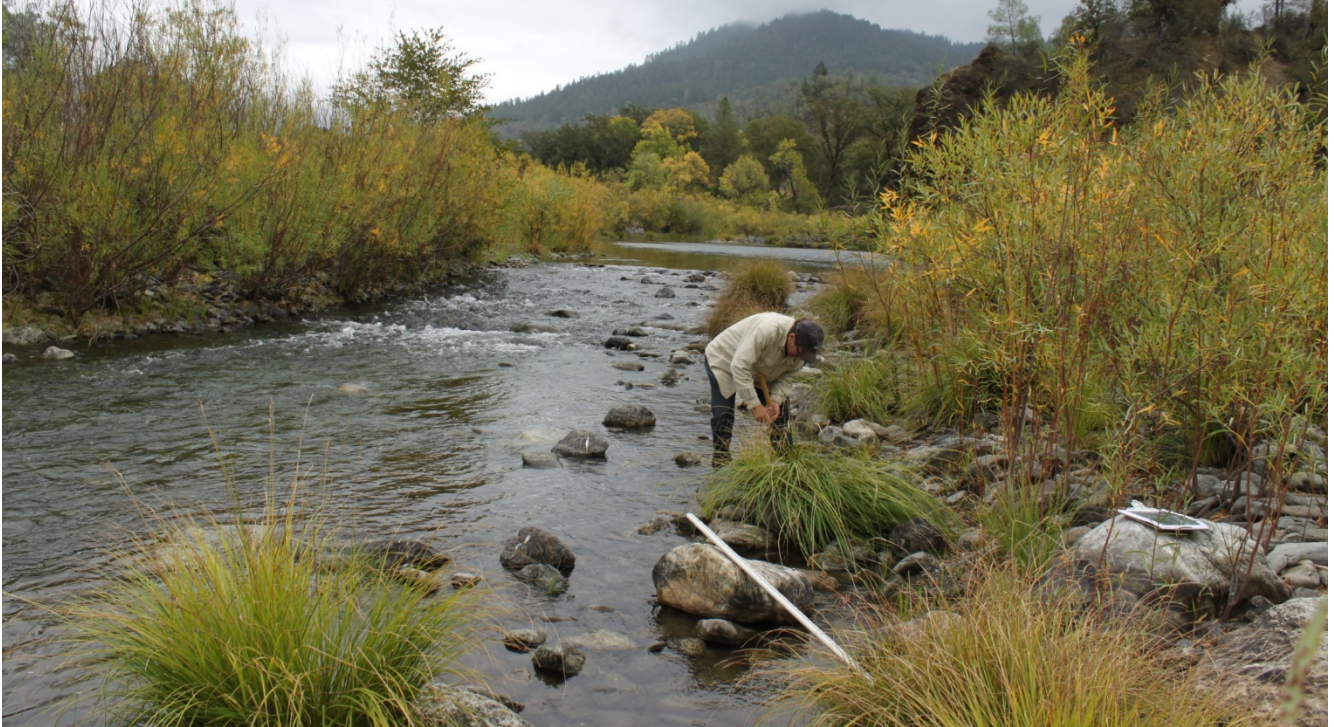
Hearst riffle (Van Arsdale release = 29 cfs), 10/14/2014.

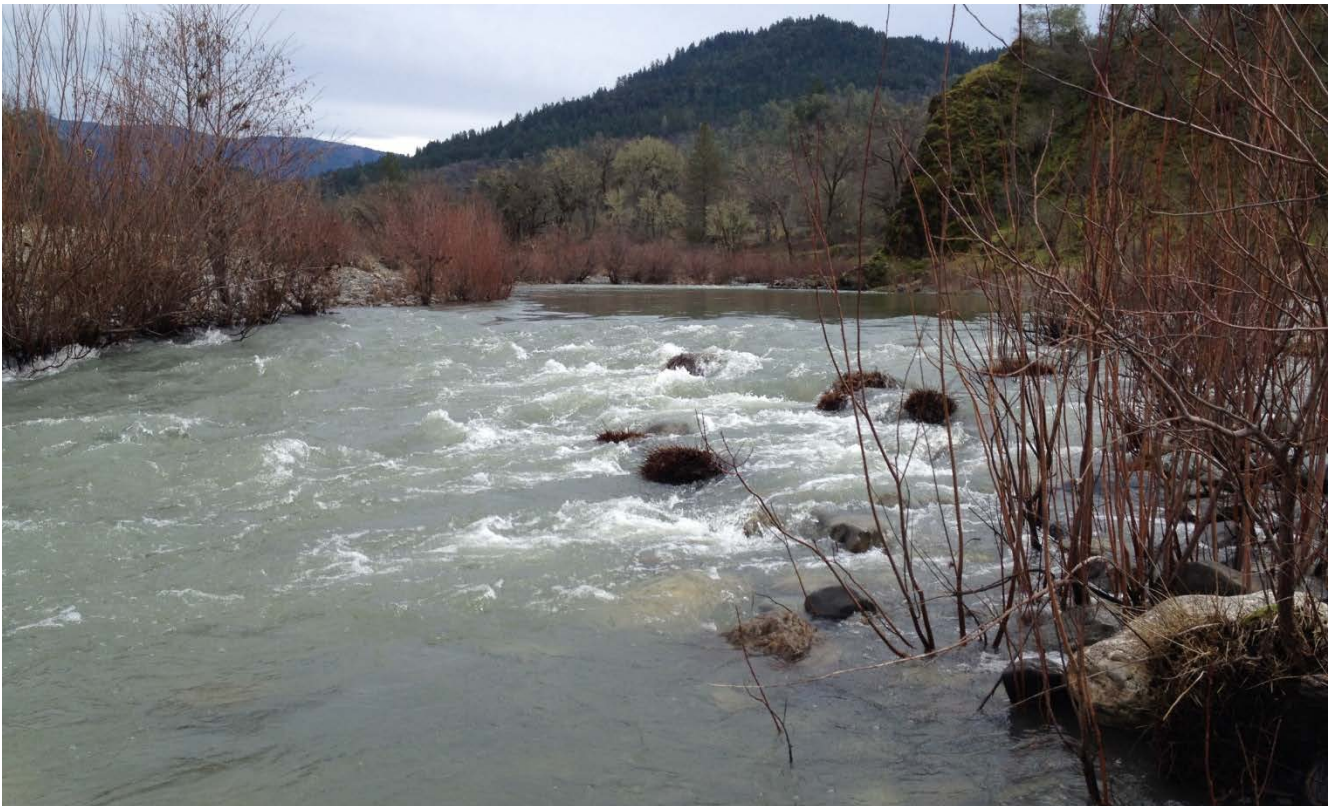
Hearst riffle (Van Arsdale release = 194.28 cfs, measured flow = 238.4 cfs), 1/15/2015.

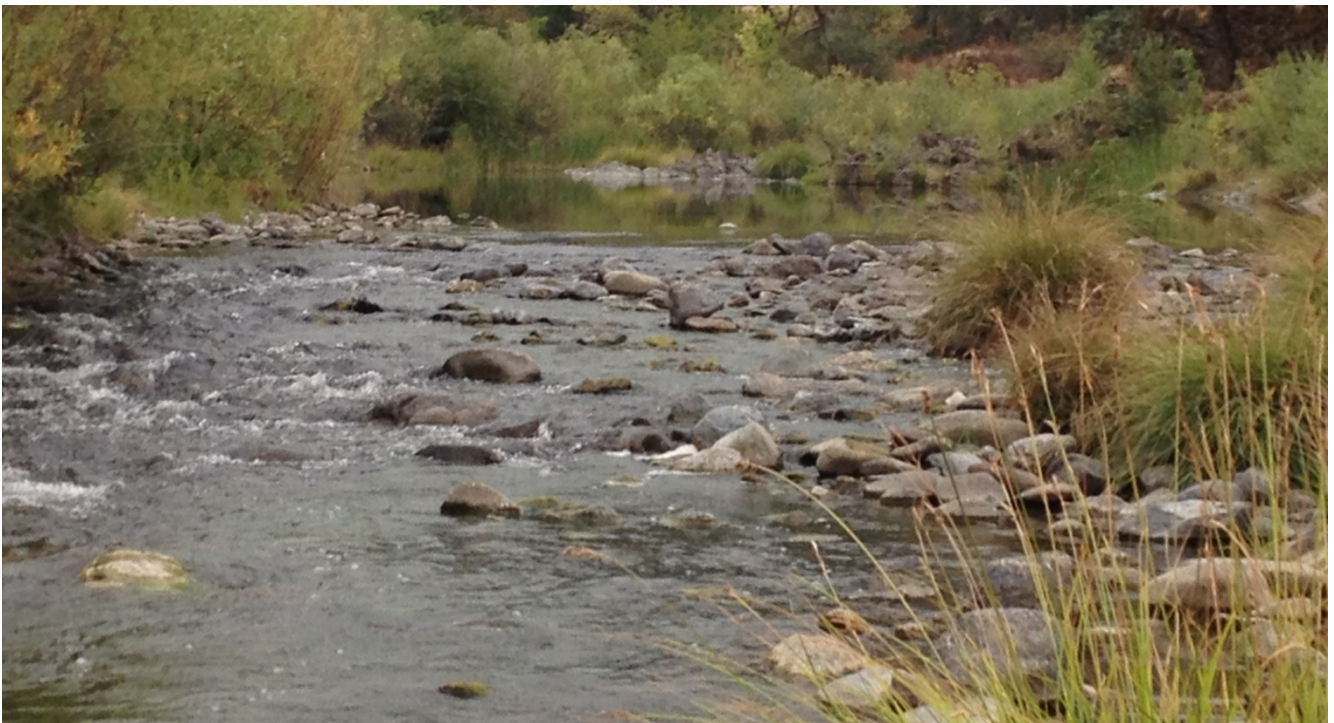
Hearst riffle (Van Arsdale release =14.69 cfs, measured flow = 9.75 cfs), 9/13/2015.
