Re: Additional Geotechnical Concerns Regarding Scott Dam in the Potter Valley Project, P-77

Technical Memorandum 01

To:	Friends of the Eel River, c/o Kamman Hydrology & Engineering Inc.	Project:	Scott Dam
From:	Scott Stephens, GE	cc:	
Date:	September 6, 2018	Job No.:	1323.100
Subject:	Scott Dam Slope Stability Analyses

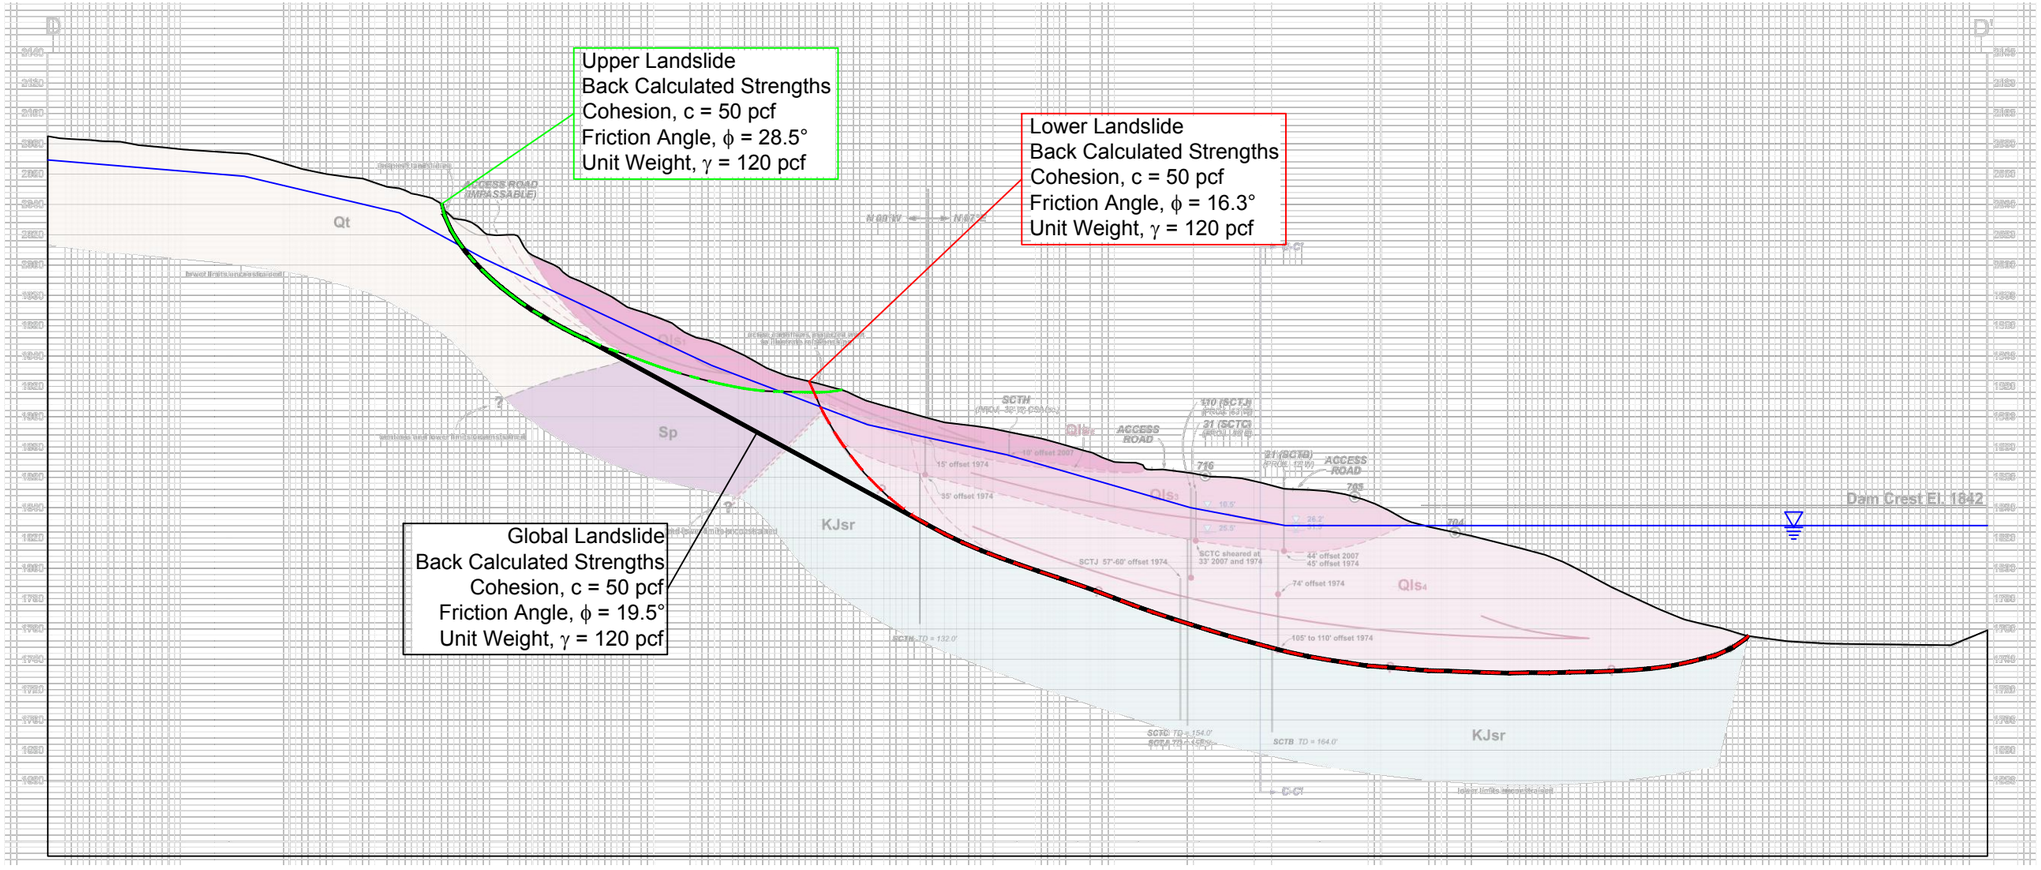
BACK CALCULATED RESULTS

Because the project area is an active landslide, we are able to back-calculate the strength along known landslide planes. To determine the residual strength of the landslide materials along the slide plane, we input Cross Section D-D' developed by PG&E into a 2-D slope stability program, (SLIDE) developed by Rocscience. Multiple slide plane soil layers were modeled within the cross section based on PG&E inclinometer data. The slide plane soil strength parameters were adjusted until the resulting slope stability factor of safety (F.S.) was 1.0, definition of marginally stable landslide. The results of our back-calculation analyses of landslide soil strengths are presented on Figure 1 and used in the pseudo-static (seismic) analyses.

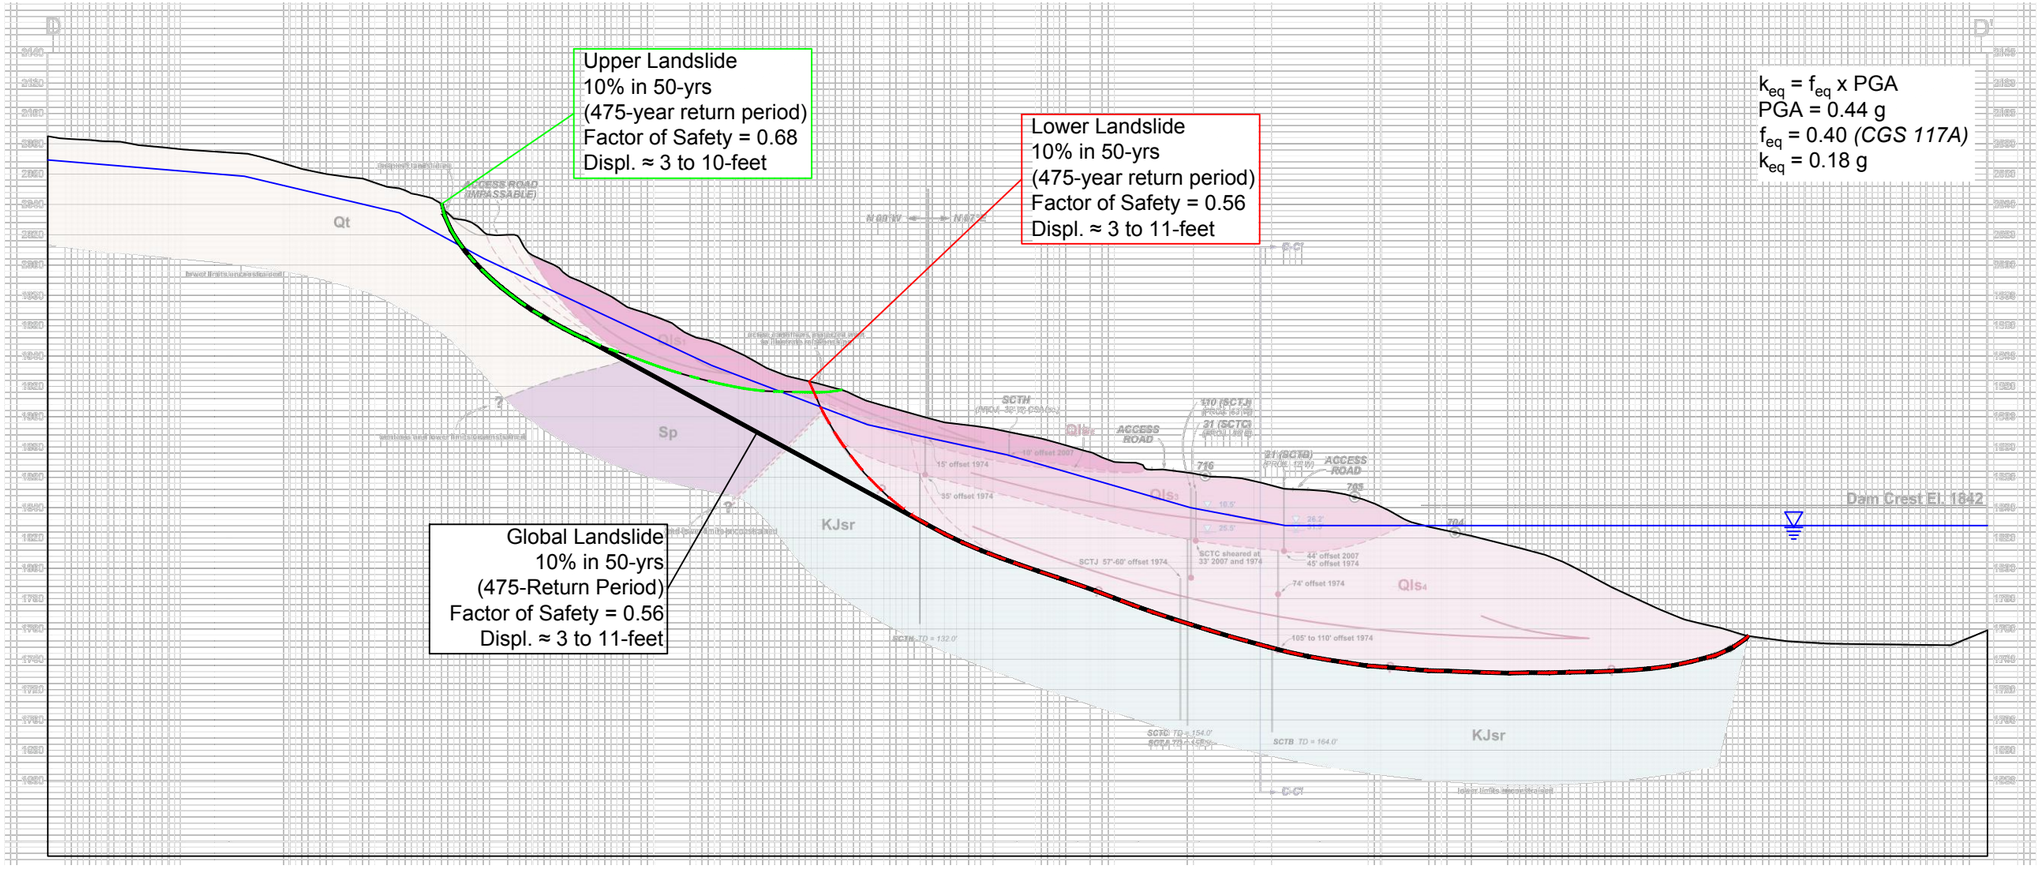
SEISMIC SLOPE STABILITY ANALYSES (10% in 50-yrs)

The reduced ground accelerations discussed above were input into our stability model utilizing the back calculated slide plane soil strength values. The results of our 10% in 50-year, 84th percentile, and 2% in 50-year pseudo-static analyses are presented on Figures 2, 3 and 4, respectively, and indicate calculated factors of safety well below 1.0, indicating landslide displacements will occur during a strong seismic event. The lower the calculated factor of safety, the more unstable the slope is and more seismic movement would be expected to occur.

We analyzed the potential slope displacement based on the procedures outlined by Bray & Travasarou (2007). The results of our analyses indicate that the anticipated range of seismic induced displacements is influenced by the soil strength profile and level of seismic shaking applied. The results of our displacement analyses indicated the landslide mass may move between 3 to 19-feet, as summarized on Figures 2, 3 and 4.
