Friends of Eel Fall Chinook Monitoring Project

Report #11

Fernbridge to Alderpoint Reconnaissance:

Plenty of Water For Chinook and the Run Continues

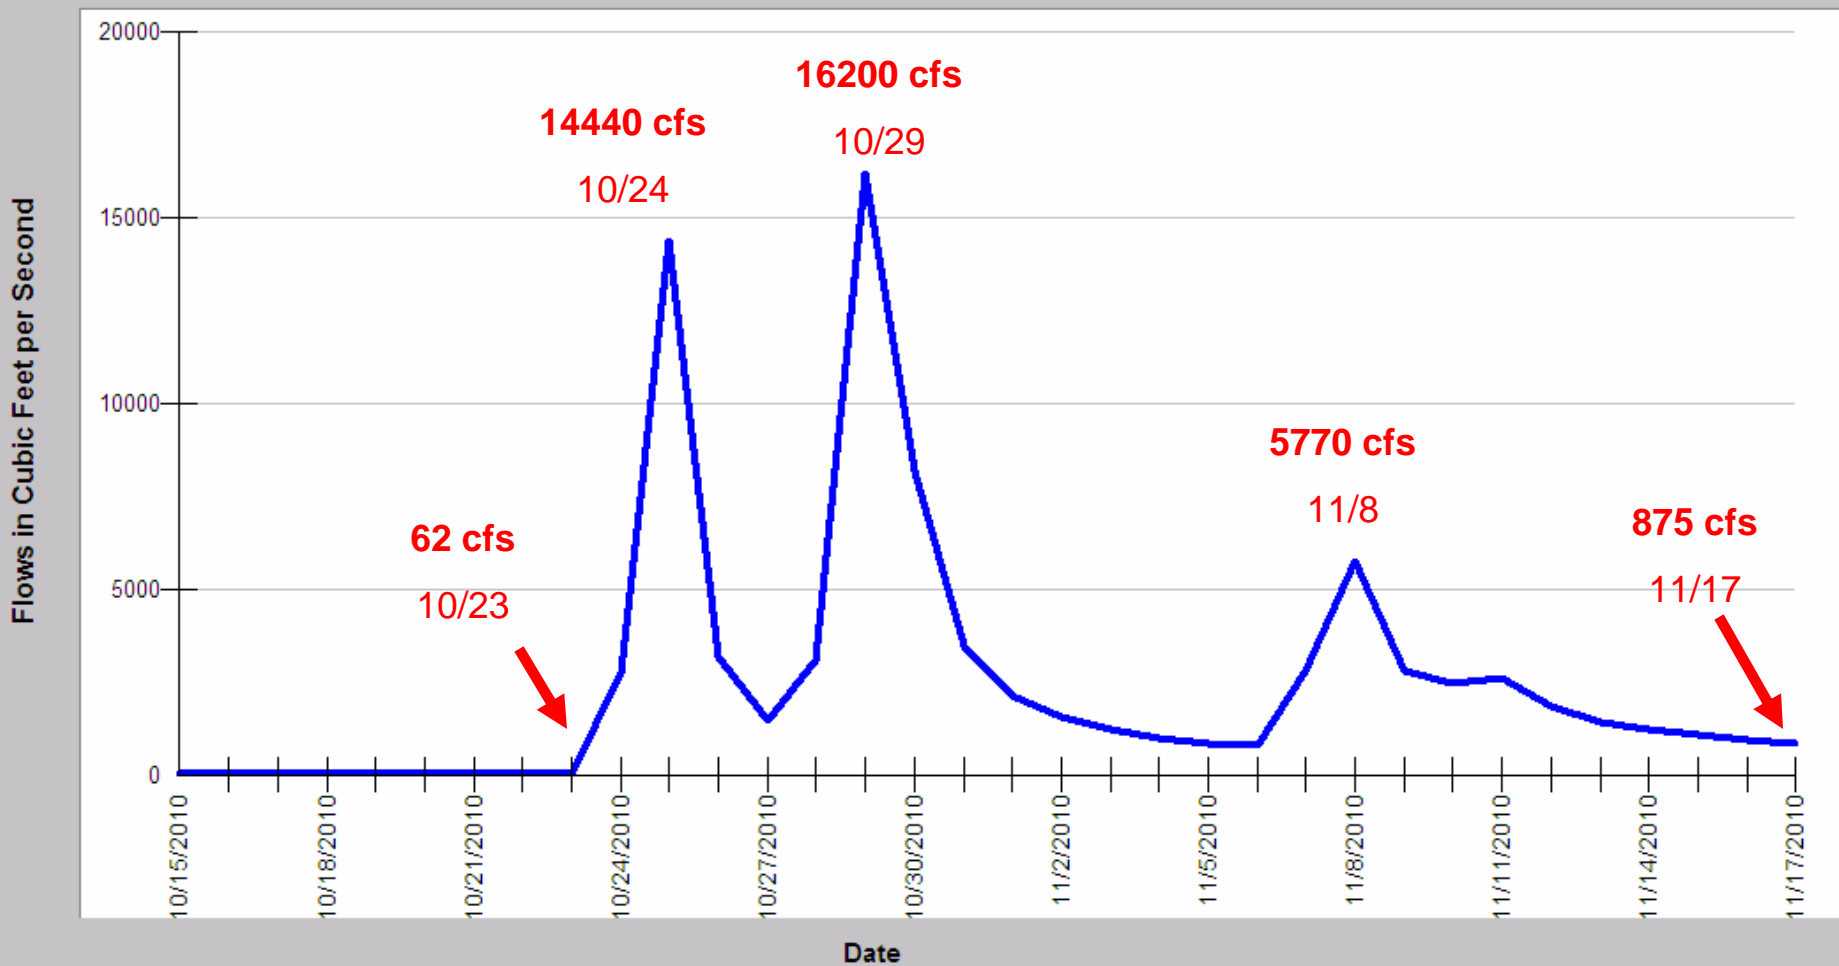
Eel River Flow at Ft Seward October-November 2010

The fluctuation of flow of the Eel River at Ft Seward indicates three major rain events in late October and early November 2010. High flows had created turbid conditions at locations like Alderpoint, but with the lack of rain after November 8, the river finally cleared a week later.

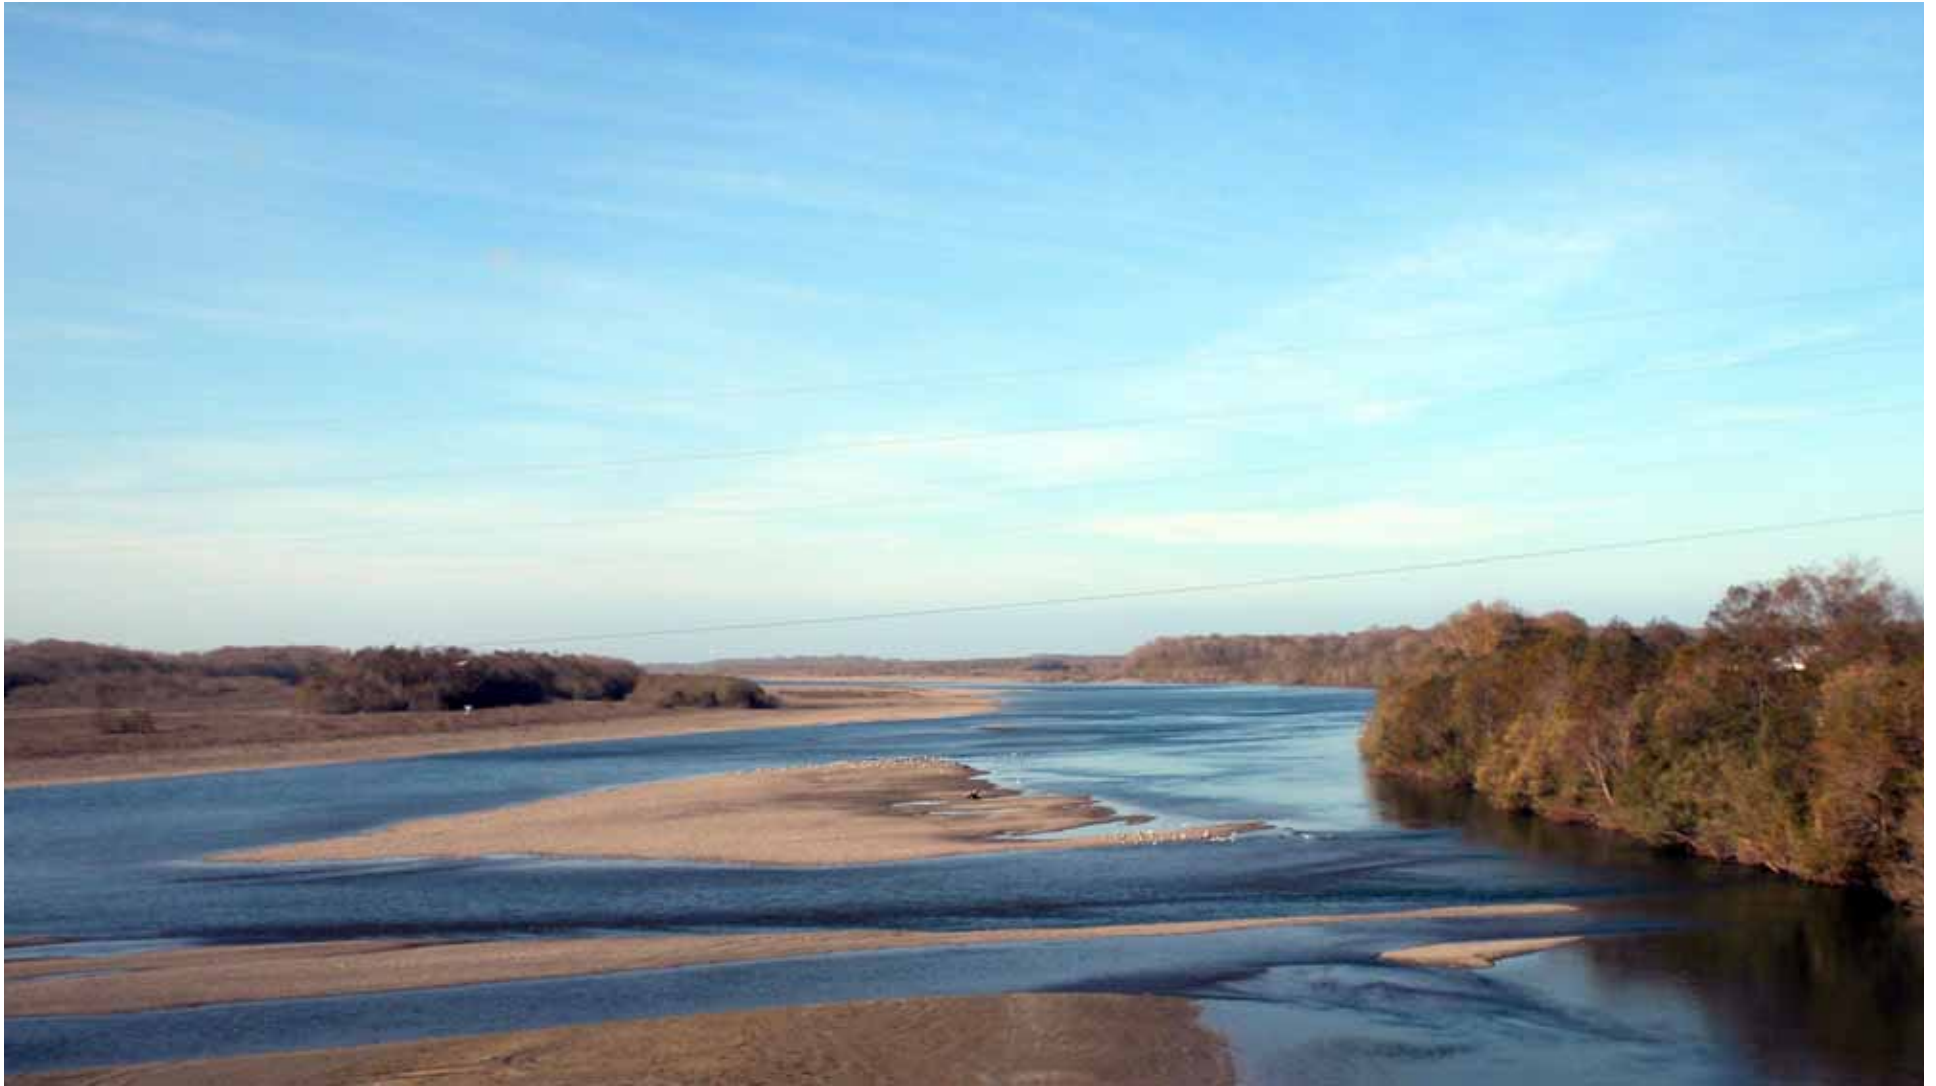
The Eel River below Fernbridge on November 16 with flow likely in the range of 2000-2500 cfs. There was ample flow for fish passage and the water clarity was 3-4 feet. (USGS flow gauge results for Scotia and Fernbridge were provisional when this report was completed).

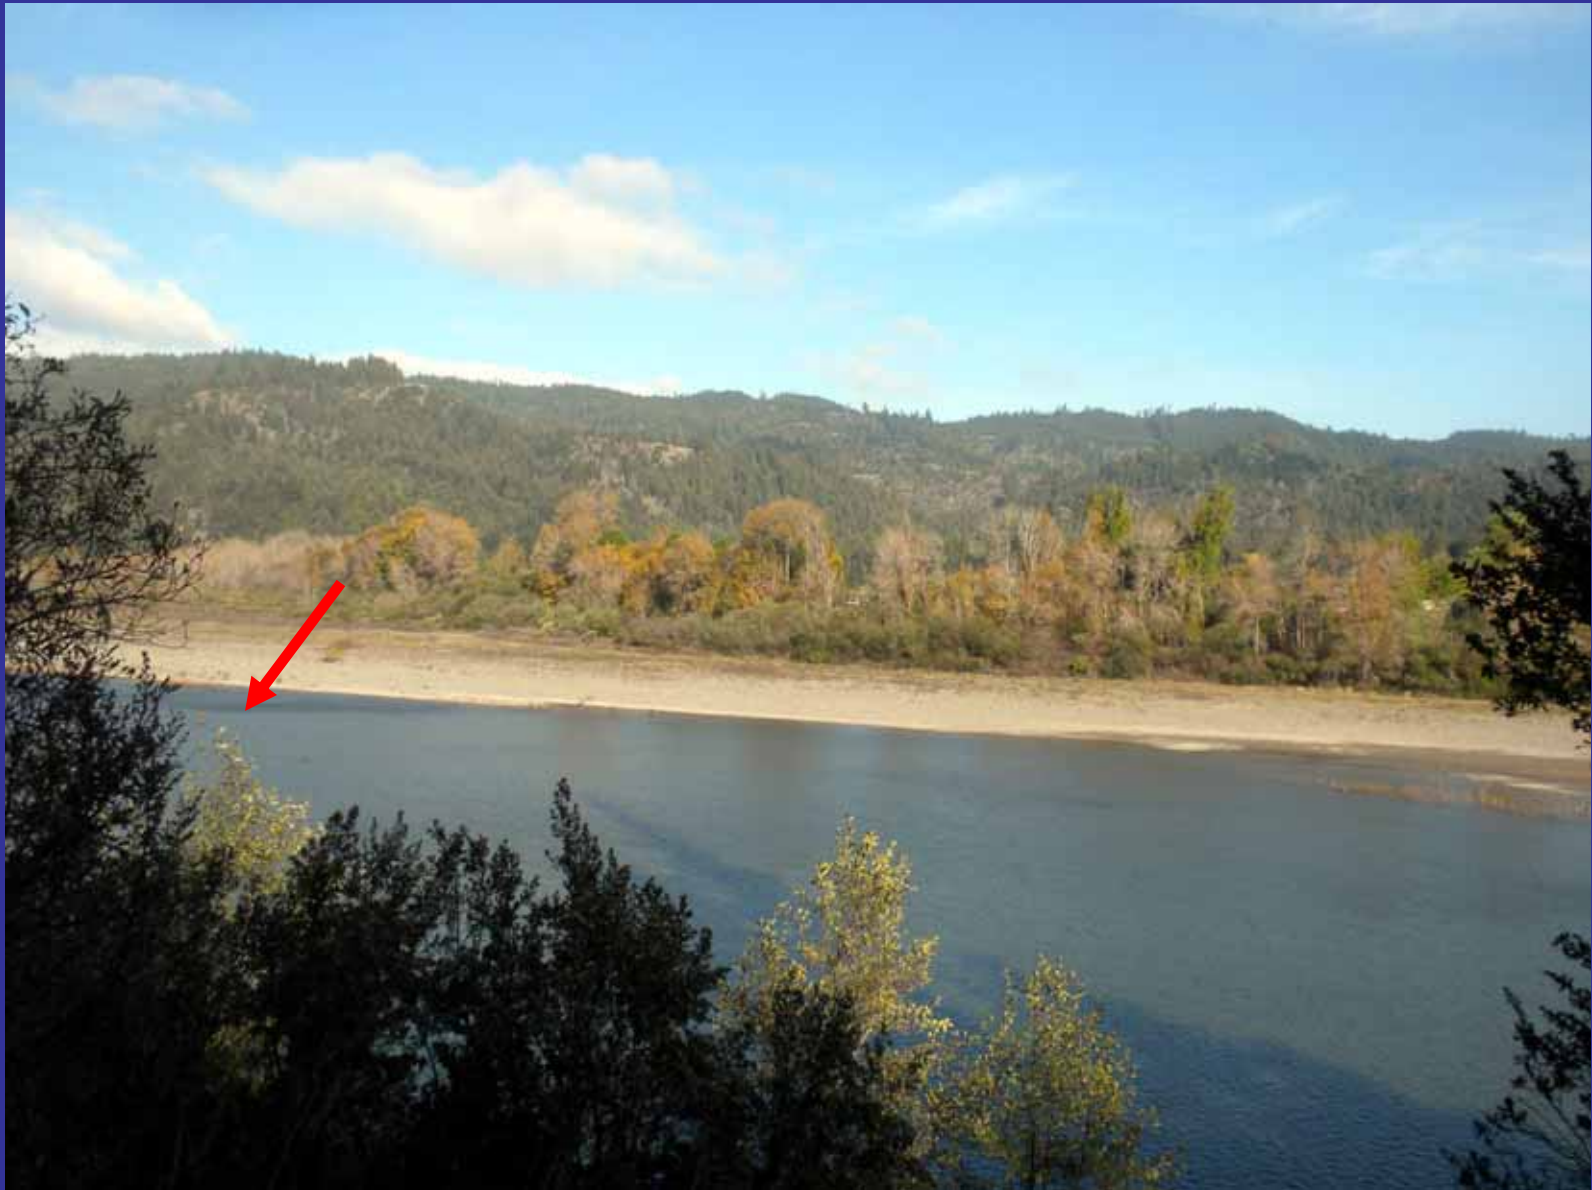
The mainstem Eel River above Bear Creek looking downstream at the Shively area index riffle (red arrow). High flows made fish observations here by Bill Reynolds only periodically feasible.

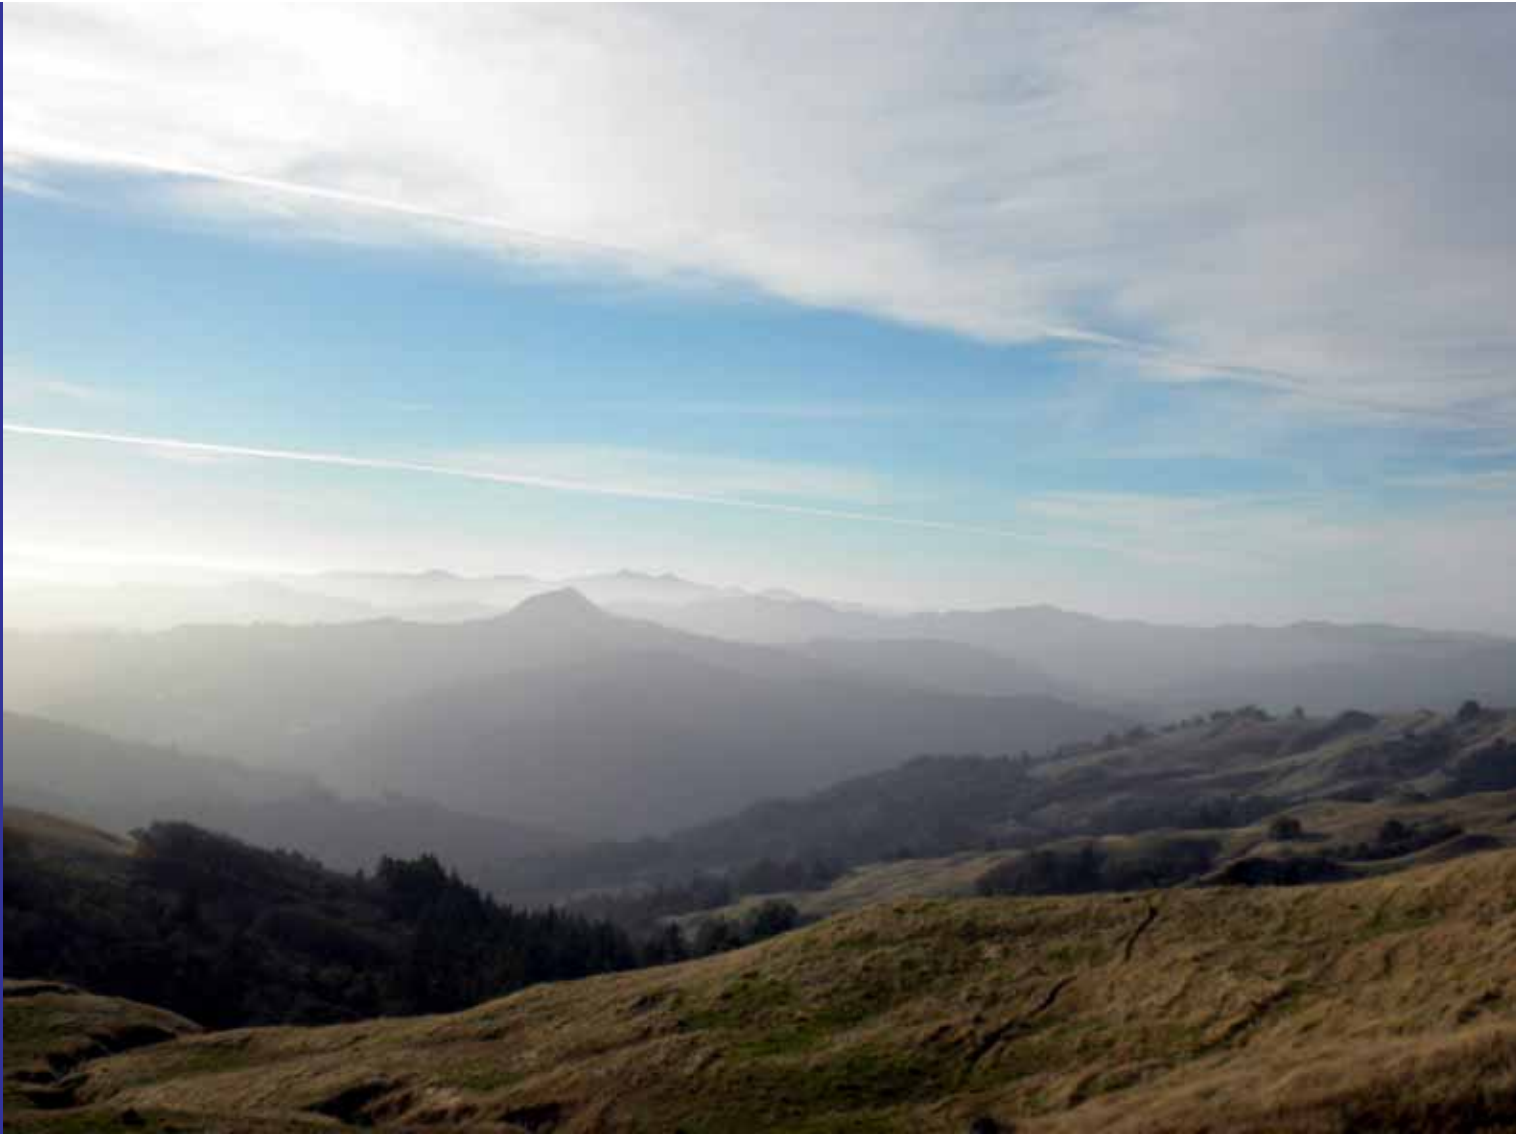
The road to Ft Seward winds up the hill from Myers Flat and this taken is from the ridge on that road looking west into the South Fork Eel River drainage. The extensive grasslands are characteristic of Central Belt Franciscan geology and the main land-forming process here is earth flows. These areas are subject to gully erosion as well as mass wasting.

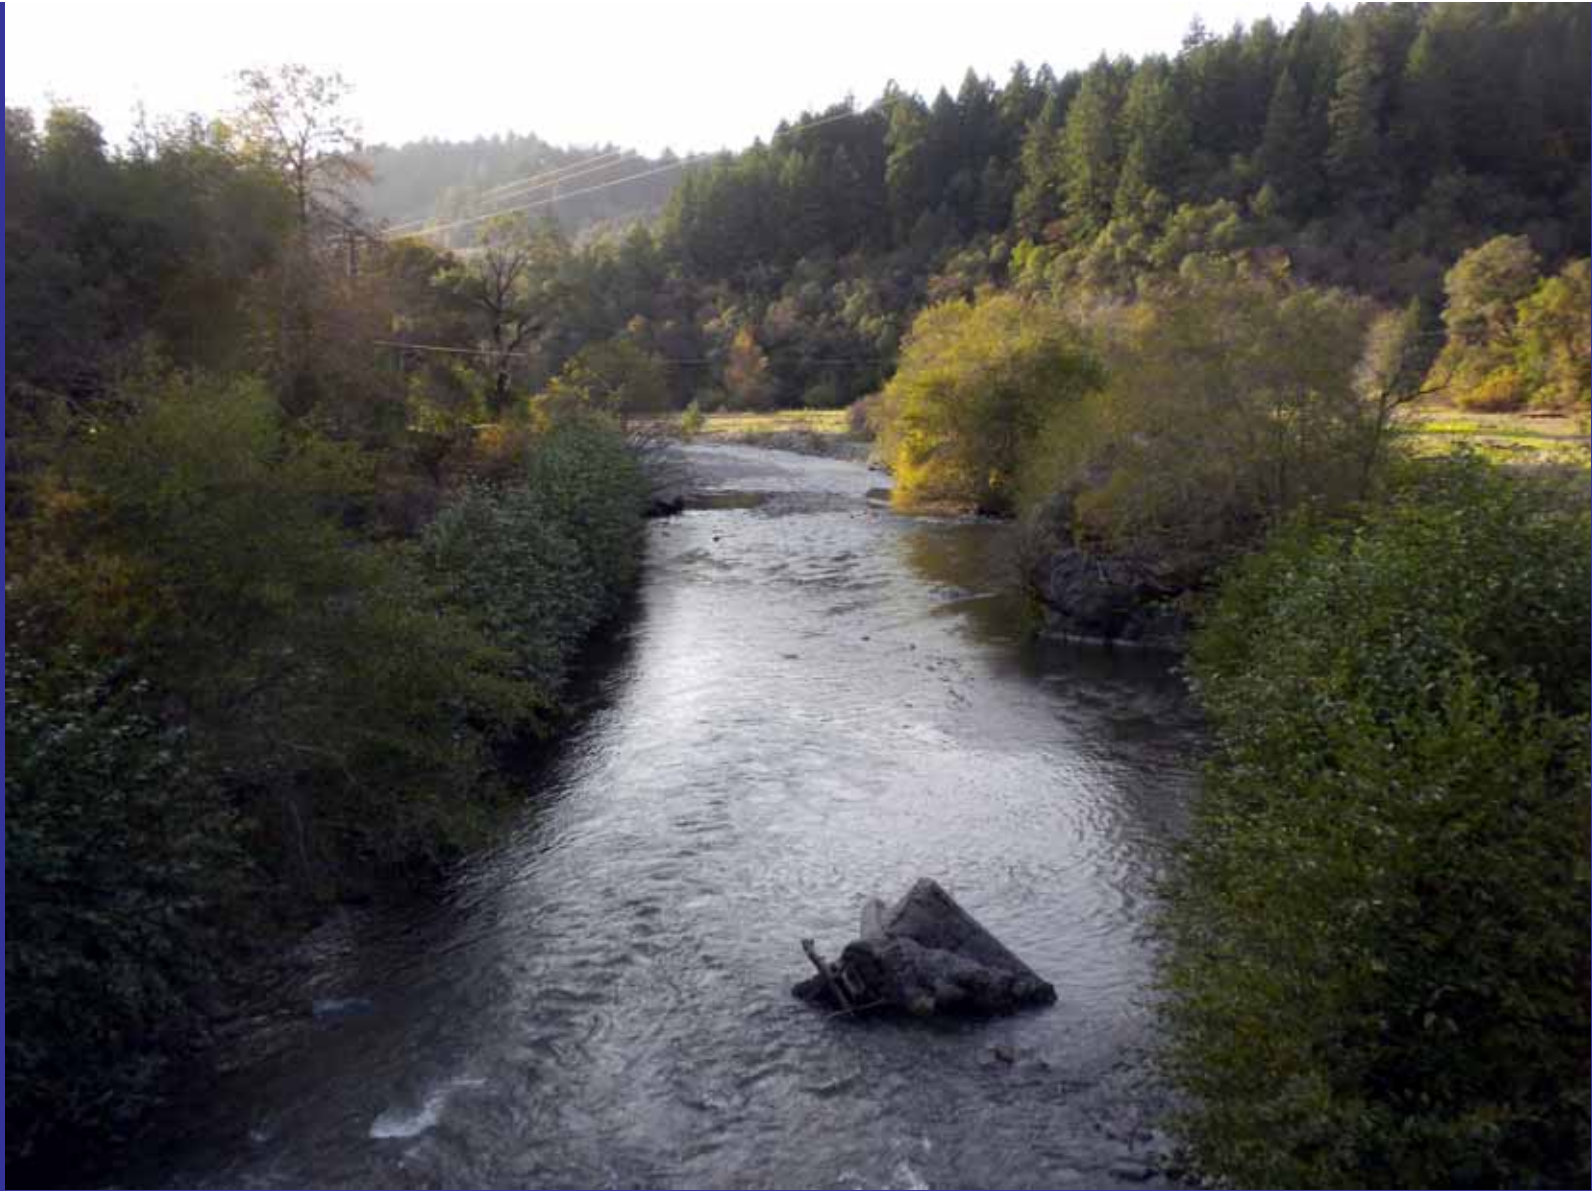
Dobbyn Creek looking downstream from the Ft-Seward to Alderpoint Road. Although flow appeared sufficient for salmon spawning, there were no fish present. Also, turbidity was high and there were other indications of problems with fish habitat quality.

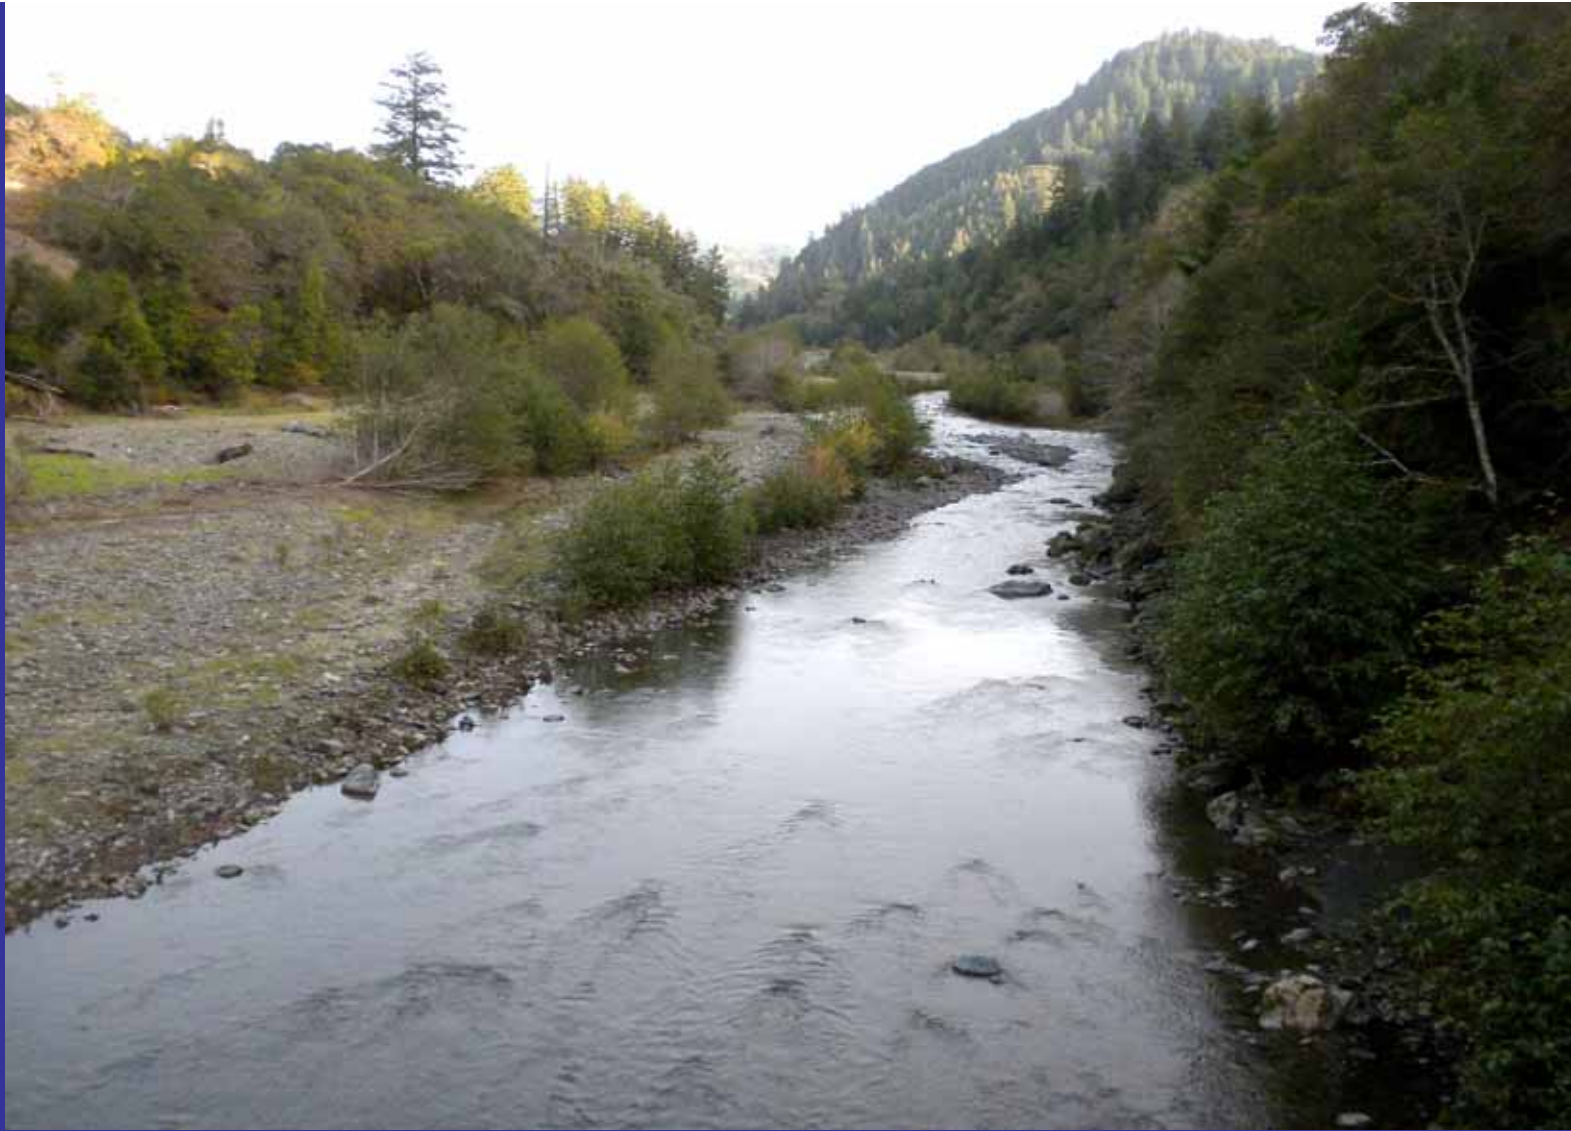
Dobbyn Creek looking upstream from the Ft-Seward to Alderpoint Road shows very disturbed conditions. The lack of pools and riffle dominated habitats, large median bed particle size and high embeddedness are all signs of sediment related cumulative effects. Alders and willows are not well established, also indicating frequent high flows and/or excess sediment transport.

- Additional counting riffles are available both above and below the bridge at Ft Seward.
- Dobbyn Creek habitat is impaired and it is apparent that the North Fork is showing more problems with sediment and cumulative watershed effects than the South Fork.

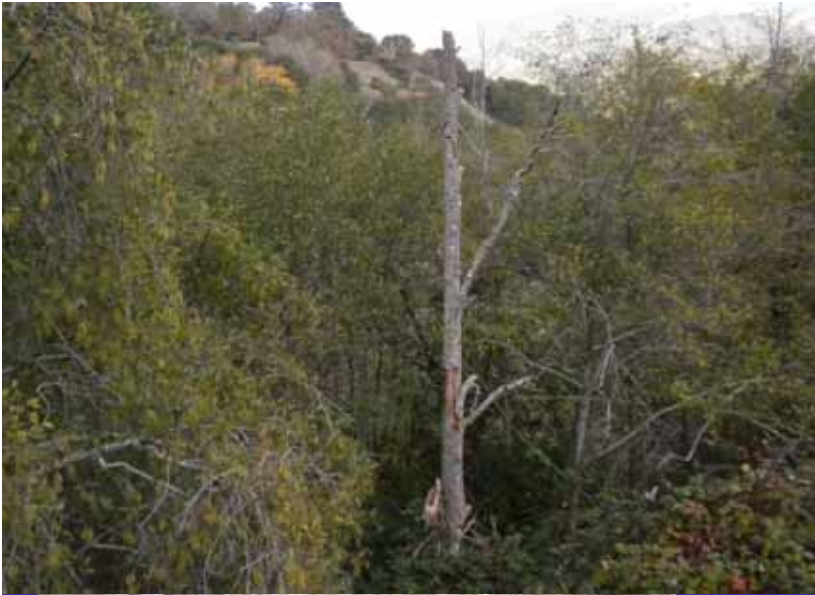
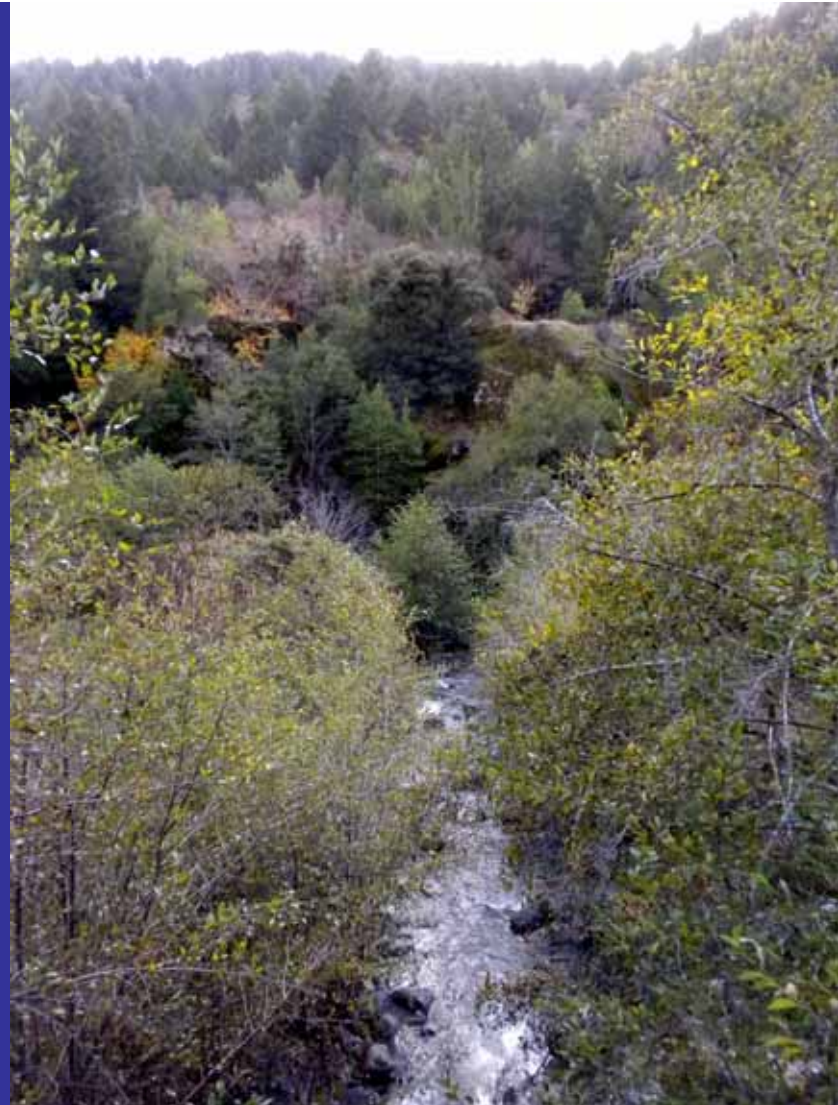
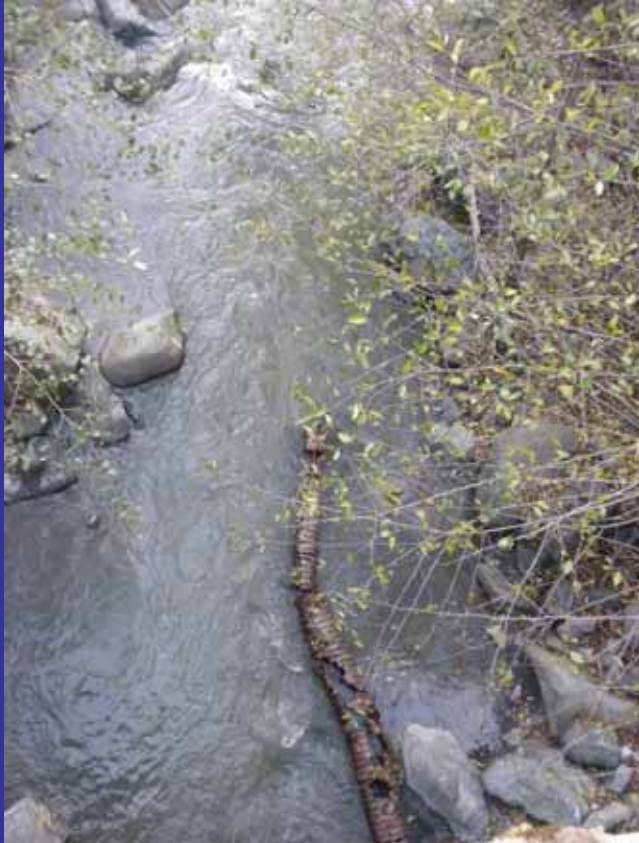
The North Fork Dobbyn Creek was grey (left) due to high turbidity and the culvert remnant indicates road failures have occurred in the drainage. The young alders (above) and dead alders just upstream of the bridge (upper left) indicate a recent channel reset.

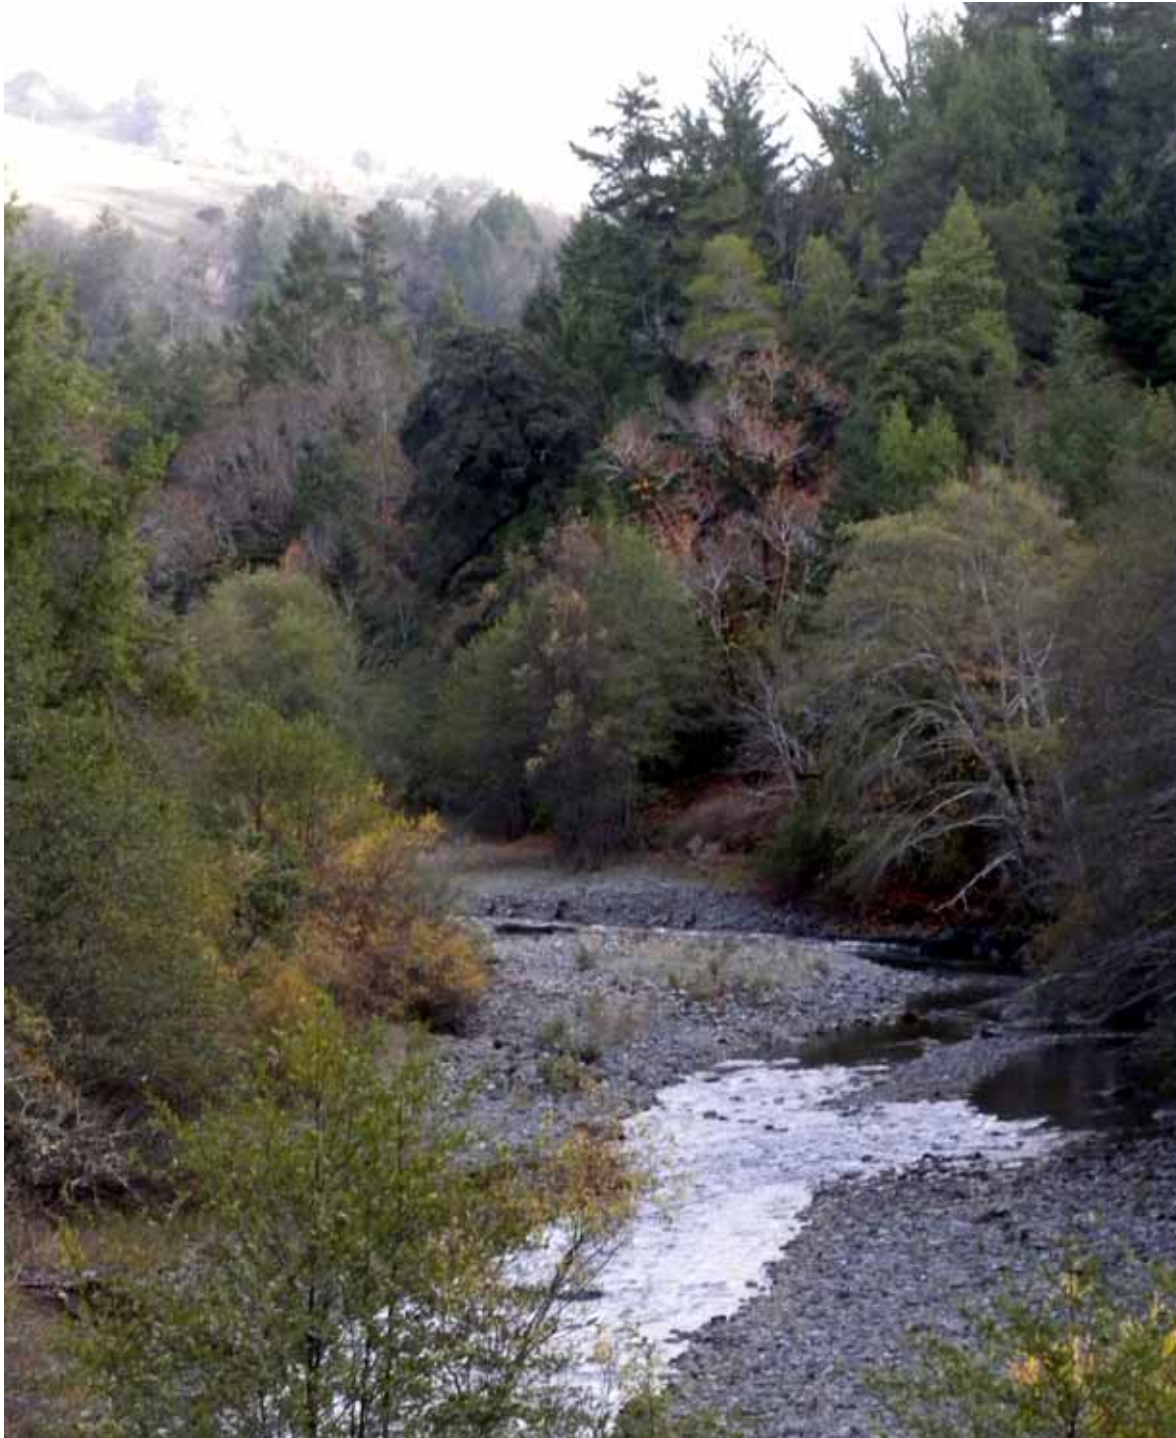
South Fork Dobbyn Creek
photo taken looking upstream
on November 16 from the Ft
Seward to Alderpoint Road.
Note that the riparian canopy
here has more mature trees
and tree species diversity than
on the North Fork indicating
better watershed health.

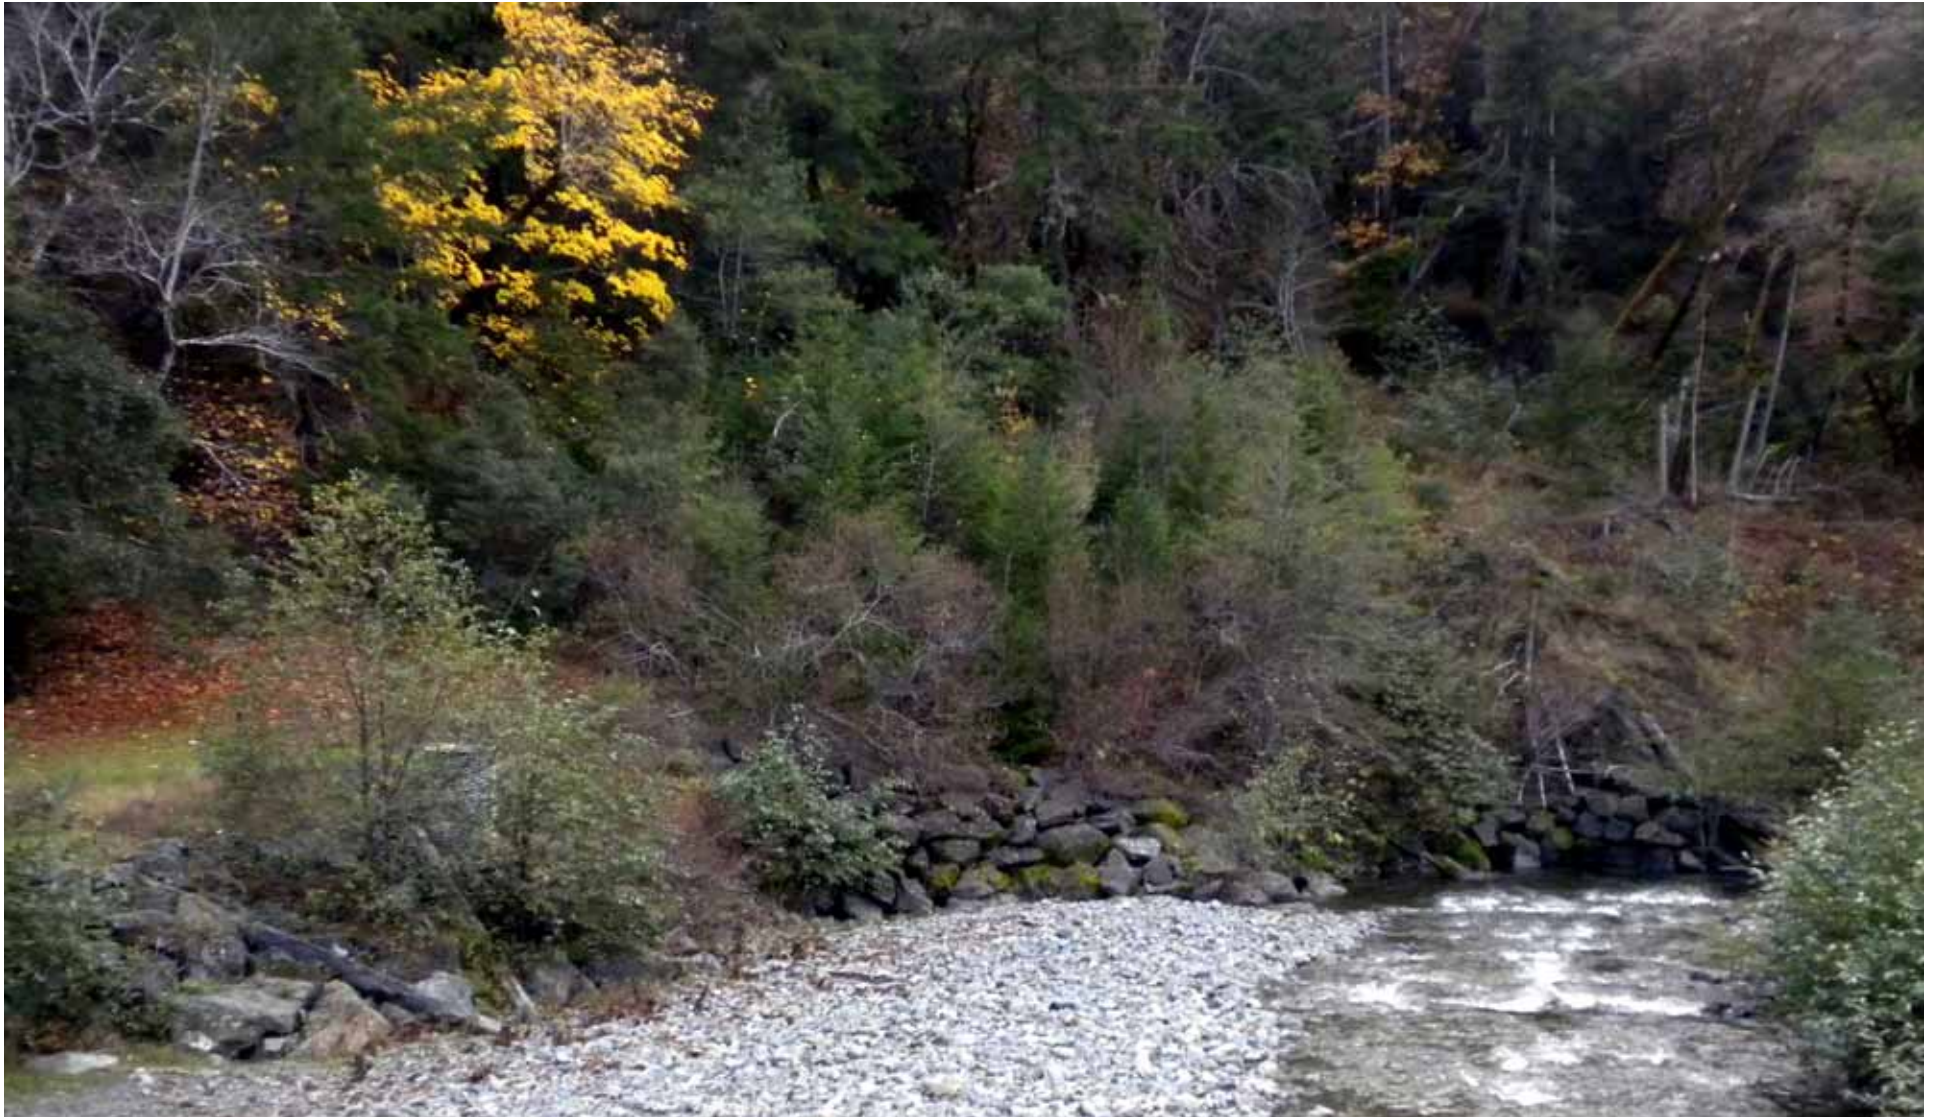
The South Fork Dobbyn Creek looking downstream from the Ft Seward-Alderpoint Road Bridge. The bank armoring at this location is likely in response to an earlier episode of bank erosion. Eroding banks are often a sign of an over-supply of sediment or increased peak discharge due to land management.

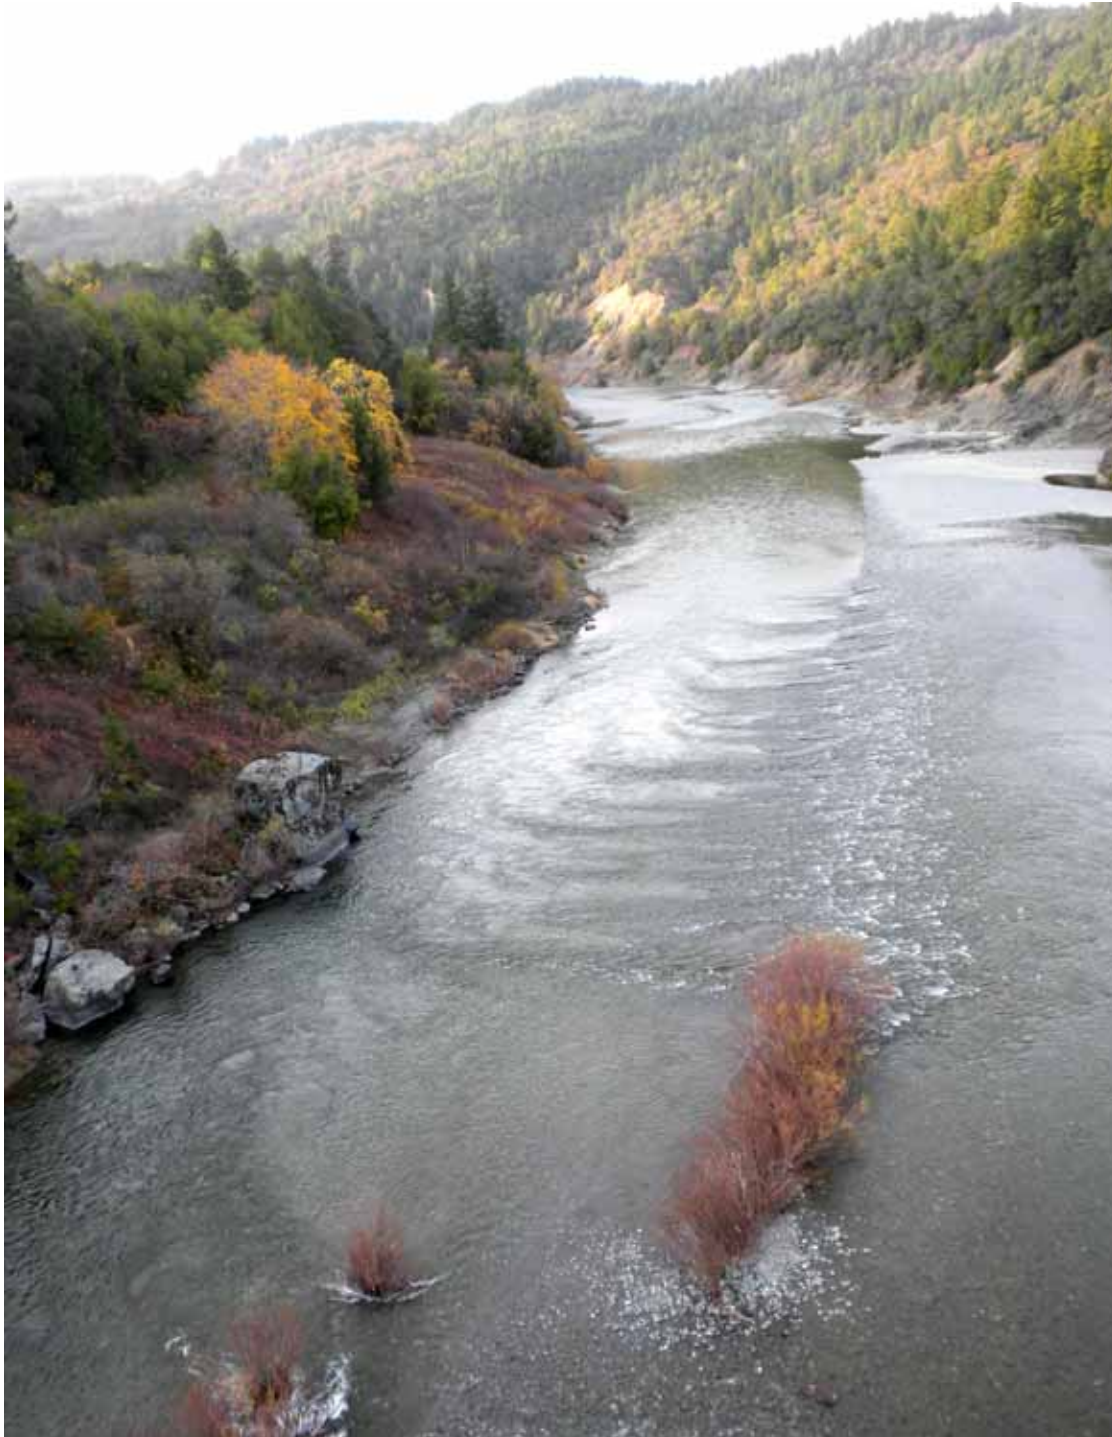
The mainstem Eel River at Alderpoint looking downstream on November 16 at 5 PM. Although the low sun angle makes it difficult to discern water clarity, there was at least four feet of visibility.

The riffle downstream that was to serve as a counting station has sufficient flow to pass adult salmon, but the side channel at left would have been an even easier passage route. Water clarity at Alderpoint limited observations from October 23 to November 15.

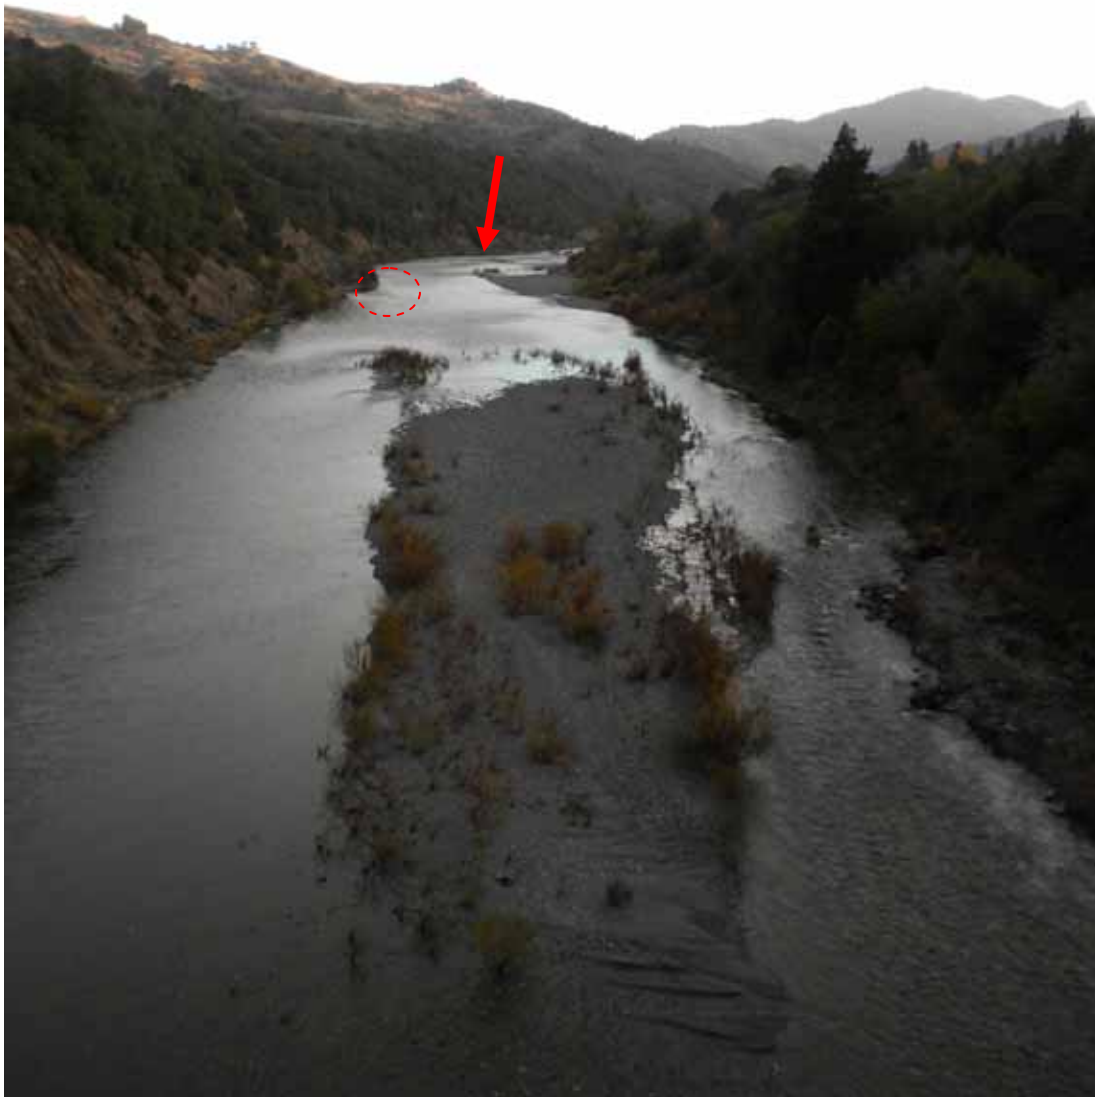
The mainstem Eel River at Alderpoint looking upstream on November 16 at 5 PM. Note that the channel at right has plenty of water to pass adult salmon; therefore, the riffle counting station below the bridge does not work at higher flows. Fish were rolling in the pool up near the bend in the distance (red circle) and the riffle (red arrow) there would be a better counting station, although less convenient. The location is accessible via an old railroad right of way access point off Eel River Road.

- Adult fish were seen rolling in a mainstem Eel River pool above the bridge at Alderpoint on the evening of November 16.
- Flows were too high to allow observations of salmon at the riffle at Alderpoint for much of the period following the October 23 storm. The river did not clear until November 15. Flows were still too high for good direct observation on November 16.
